GROVE CITY
COLLEGE

PRESERVATION PLAN

GROVE CITY COLLEGE HISTORIC CAMPUS PRESERVATION PLAN

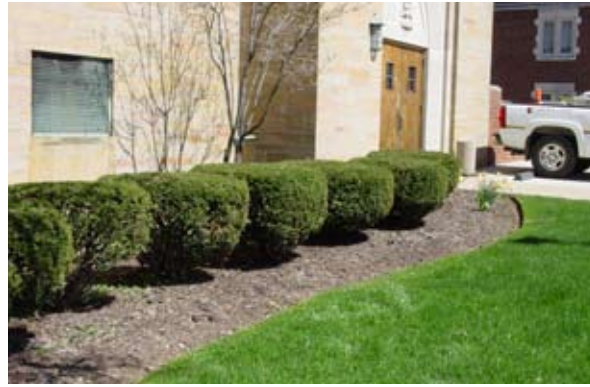
Pruning: The majority of shrub plantings are overly manicured and improperly pruned. It is recommended that shearing of shrubs be discontinued and that hand pruning and thinning be utilized instead to retain a plant's natural growth habit. A maintenance program of pruning of campus and street trees should be considered every two to three years to be implemented either by the grounds crew or by a professional company.

Manicured yews along Crawford Hall

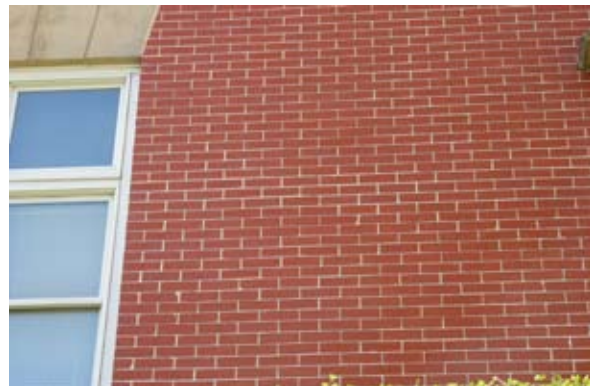
Maintain masonry mortar joints to be of like material, color and size: note joints are larger than original.

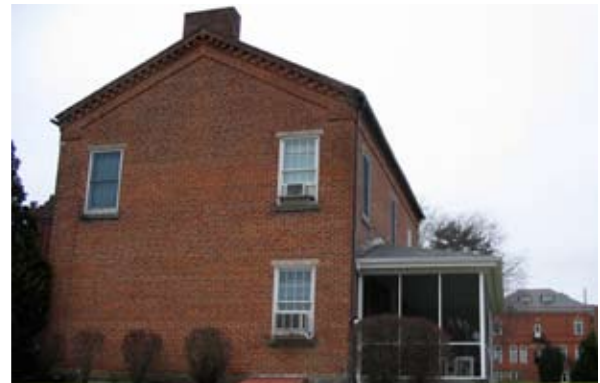
Unightly window air conditioning units detract from the historic visual character of the building.

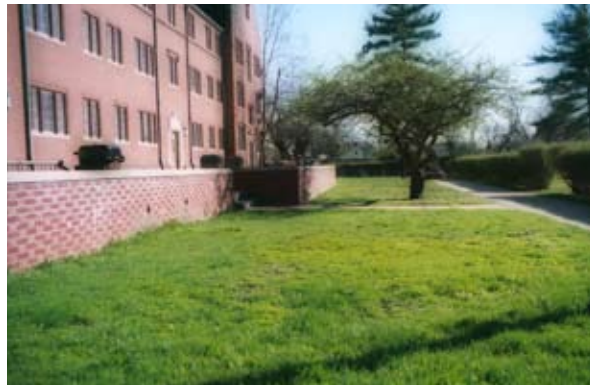
Flowering shrubs and more trees are needed here.

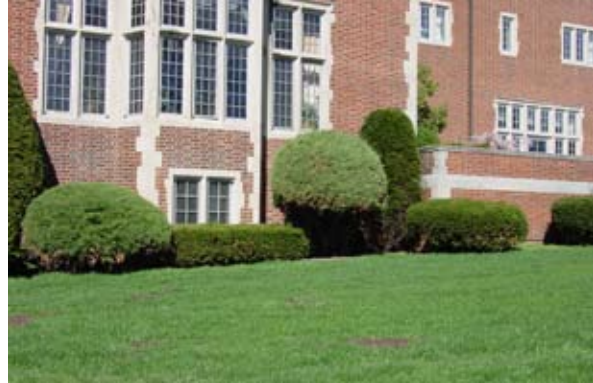
Manicured shrubs on south facing facade.

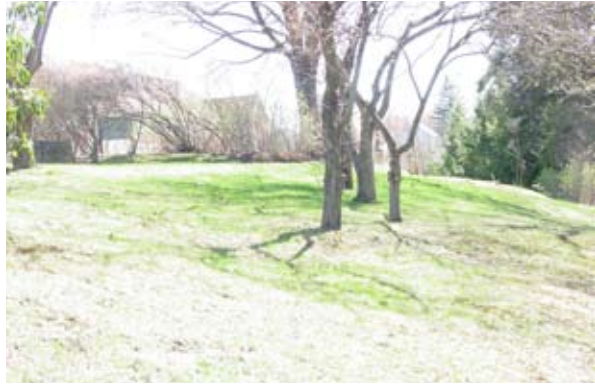
This hillside was once covered with wildflowers.
