PRESERVATION PLAN

GROVE CITY COLLEGE

The purpose of this plan is to outline recommendations for the preservation, conservation and continued use of the historic landscape and buildings of Grove City College.

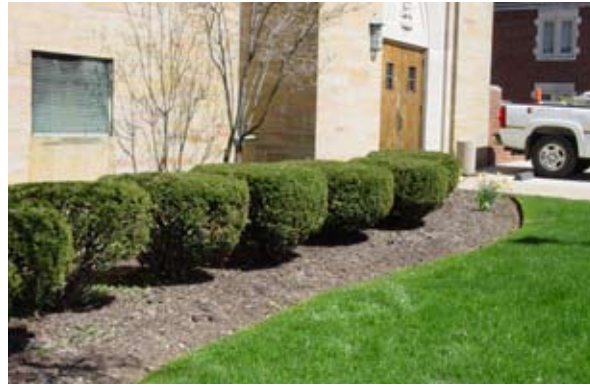
Manicured yews along Crawford Hall

Pruning: The majority of shrub plantings are overly manicured and improperly pruned. It is recommended that shearing of shrubs be discontinued and that hand pruning and thinning be utilized instead to retain a plant's natural growth habit. A maintenance program of pruning of campus and street trees should be considered every two to three years to be implemented either by the grounds crew or by a professional company.

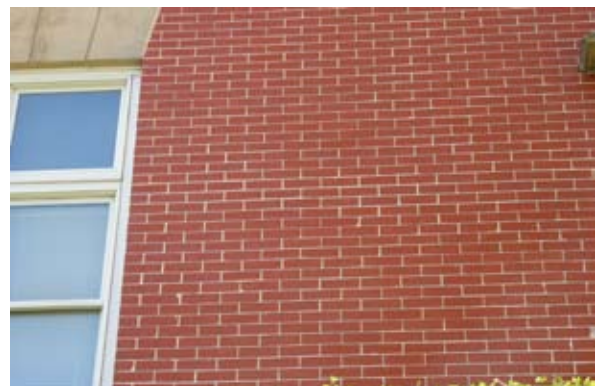
Maintain masonry mortar joints to be of like material, color and size; note joints are larger than original.

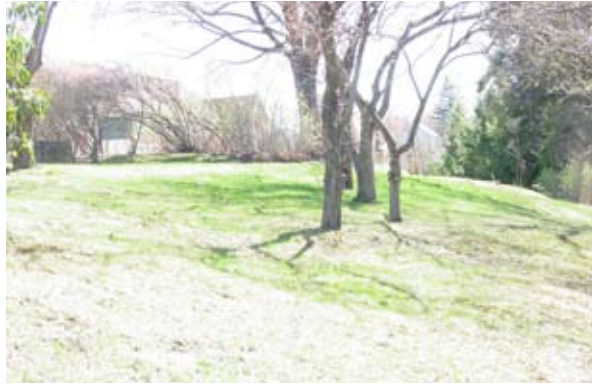
This hillside was once covered with wildflowers.
