# HISTORIC AGRICULTURAL SURVEY REPORT

*Washington & Greene Counties, Pennsylvania  
2007-2008*

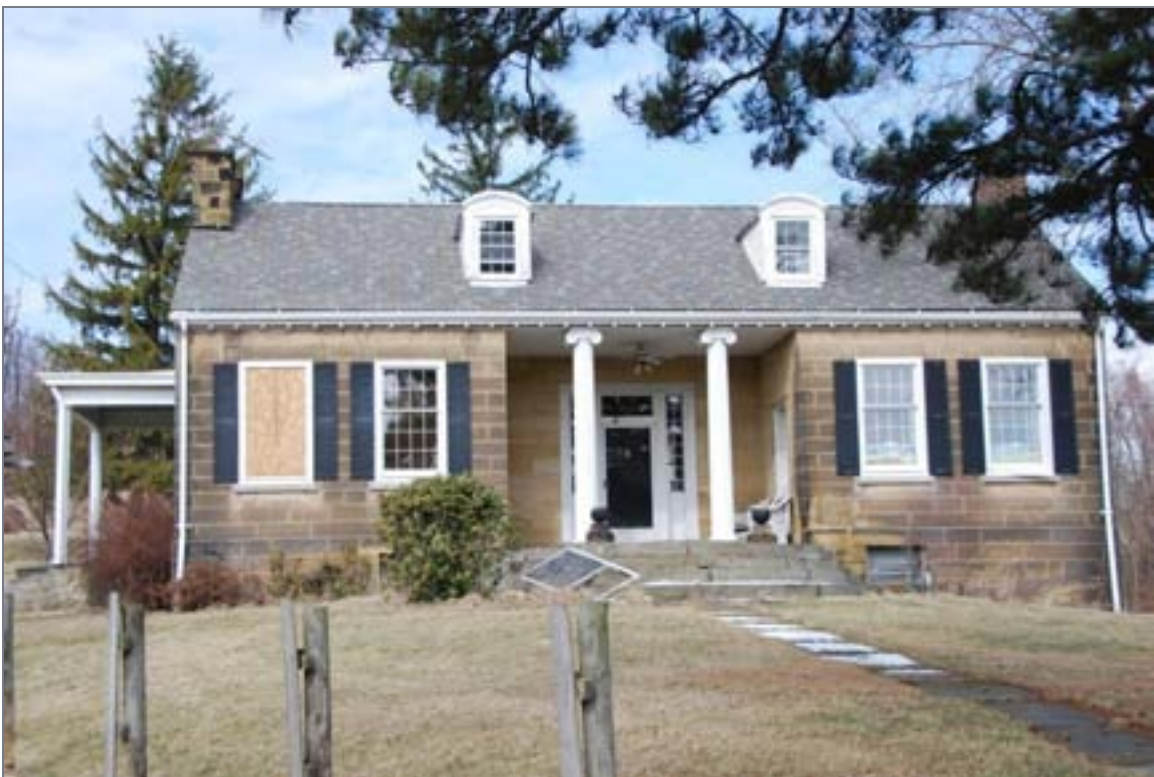
*Side entry portico with broken transom lights and round Doric columns*

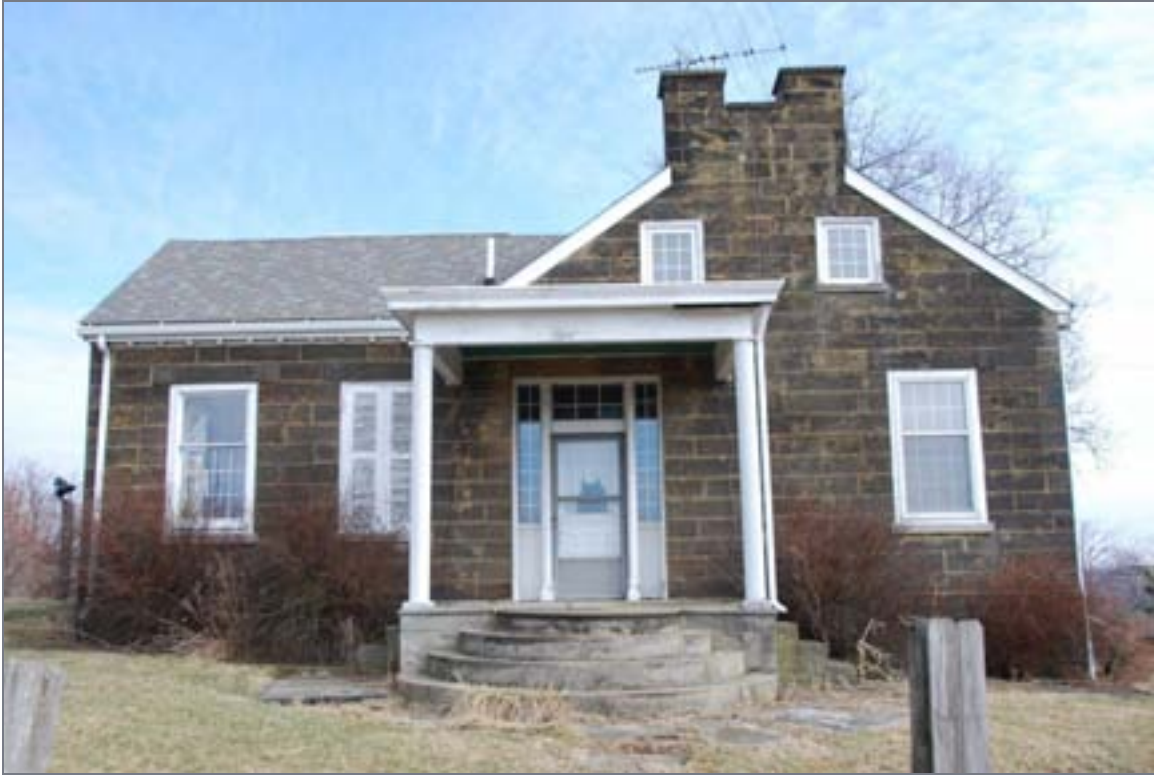
Several other farmhouses have the basic rectilinear form inspired by Classical architecture, but boast identifying features of the Greek Revival style.

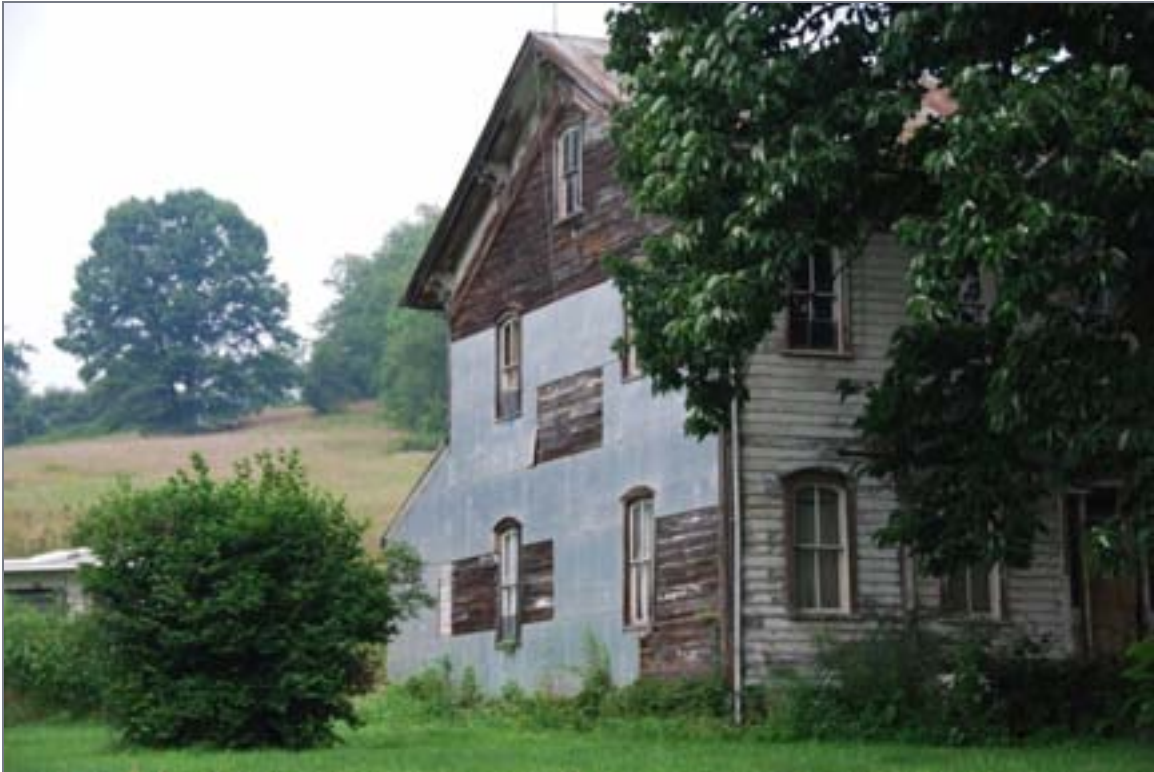
***#802008—30 Red Fox Rd. Hickory, Mt. Pleasant Township, Washington County***

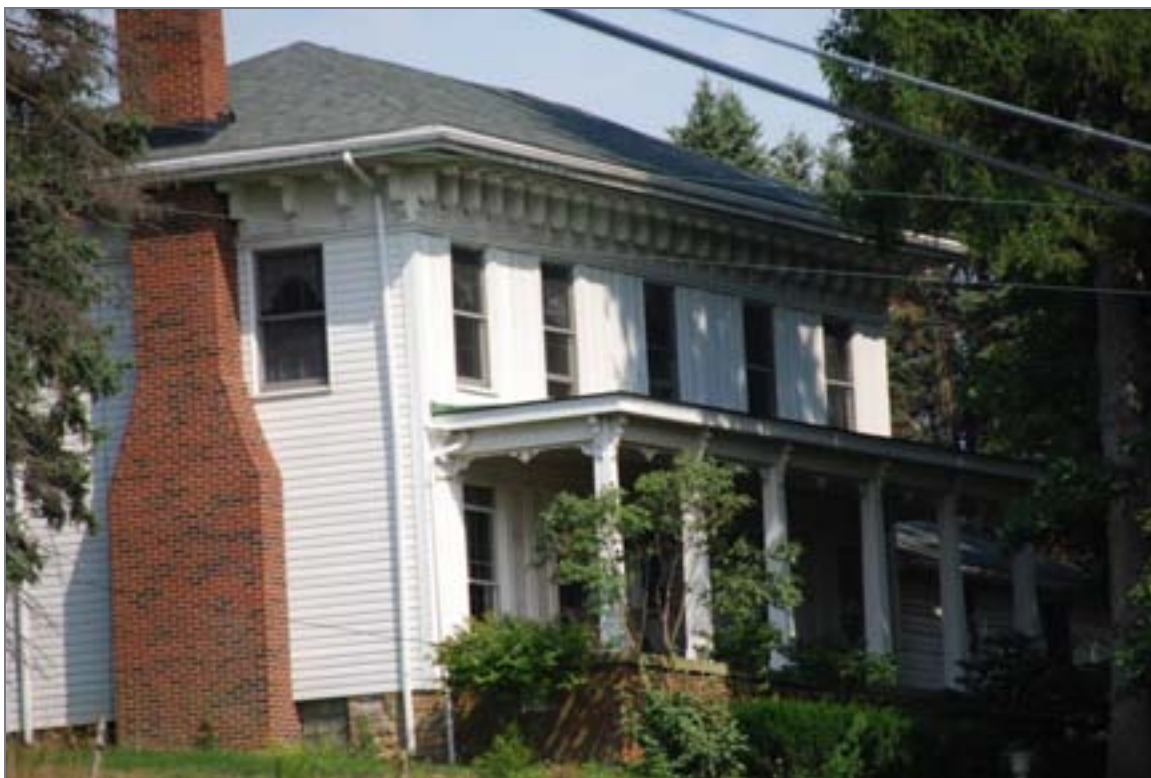
**#802062—1446 N Rt. 18 Hickory, Smith Township, Washington County**

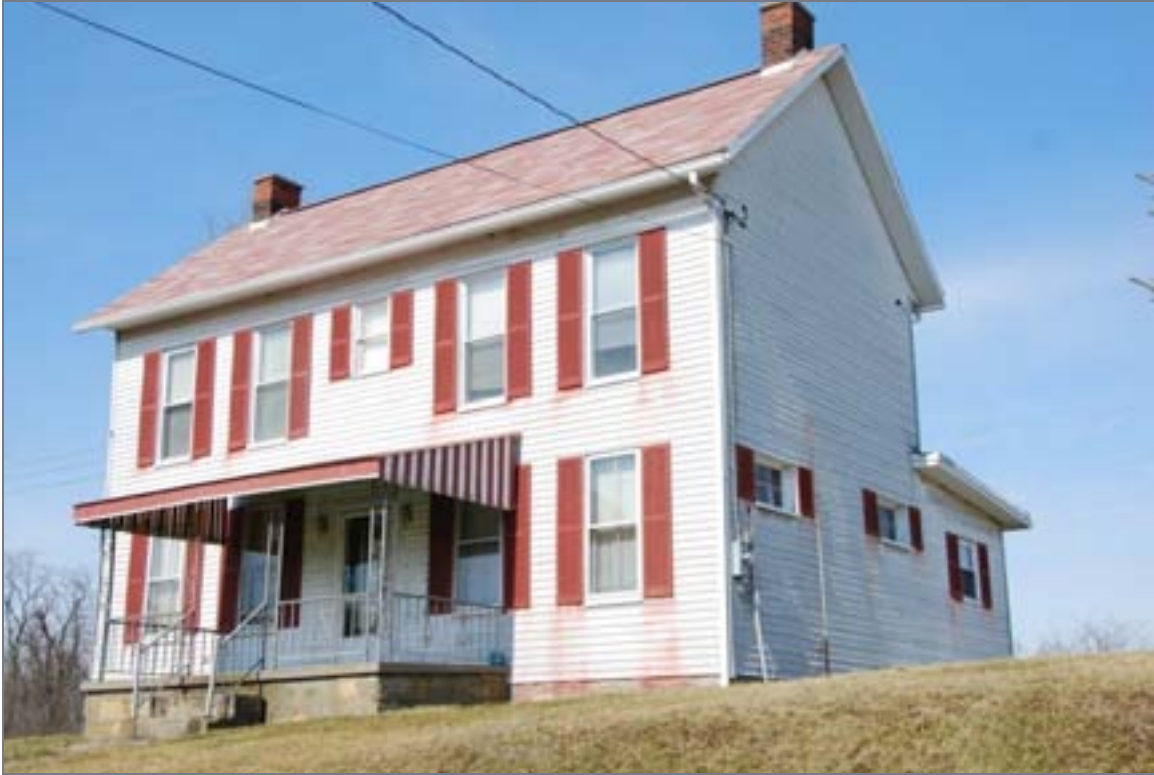
*#803104--113 Pitcock Run Rd., Waynesburg, Whiteley Township, Greene County*

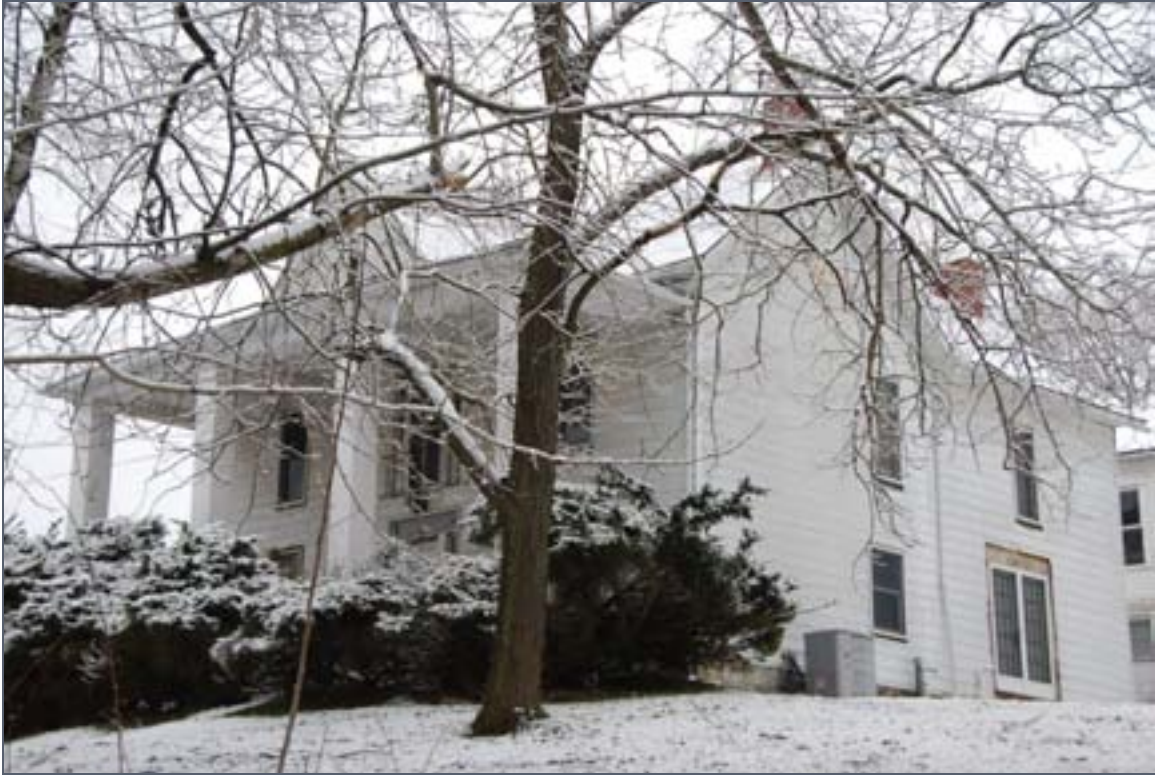
*#802871--1680 Toms Run Rd., Holbrook, Jackson Township, Greene County*

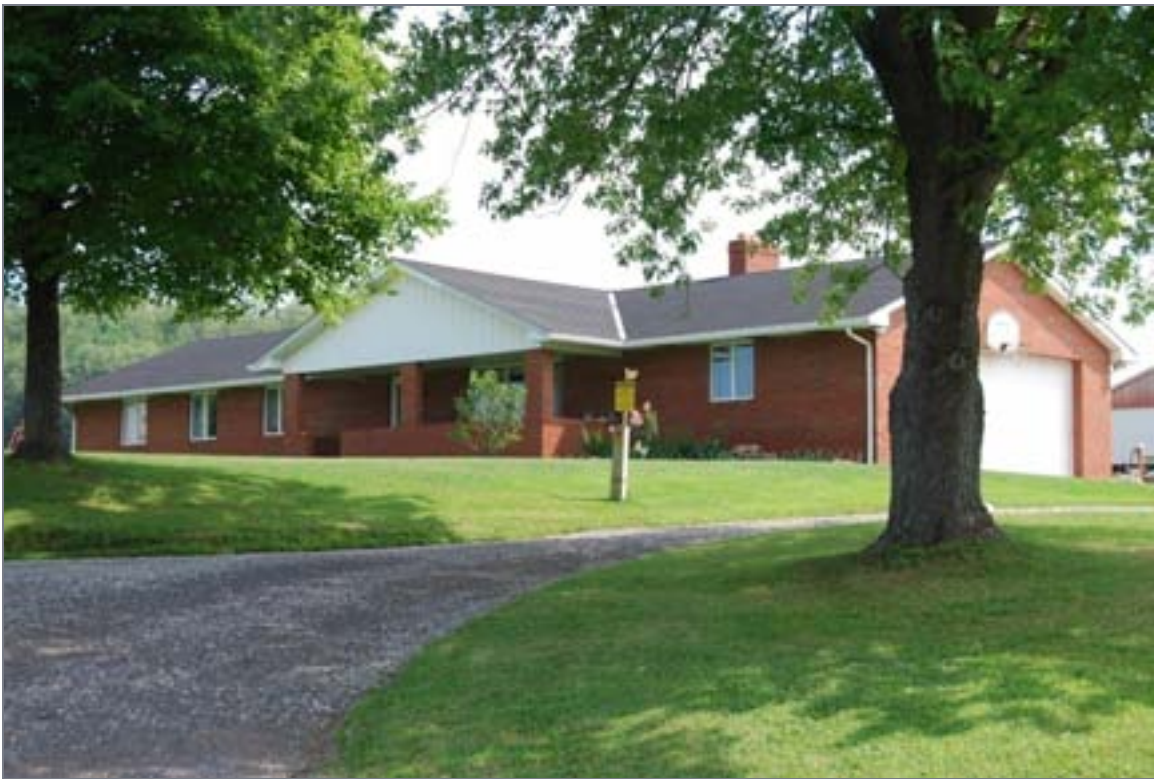
*#802040—714 Campbell Rd. Burgettstown, Robinson Township, Washington County*

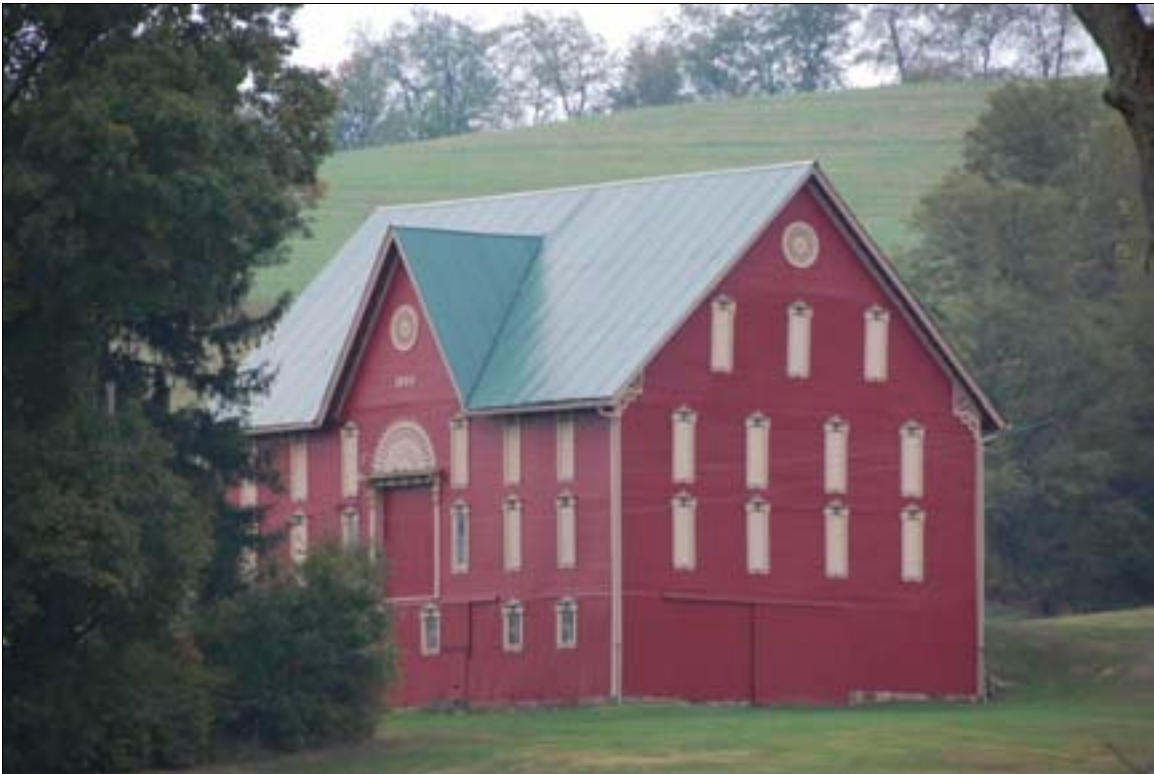
*#802532 –First St., Taylorstown, Washington County Blaine Township*

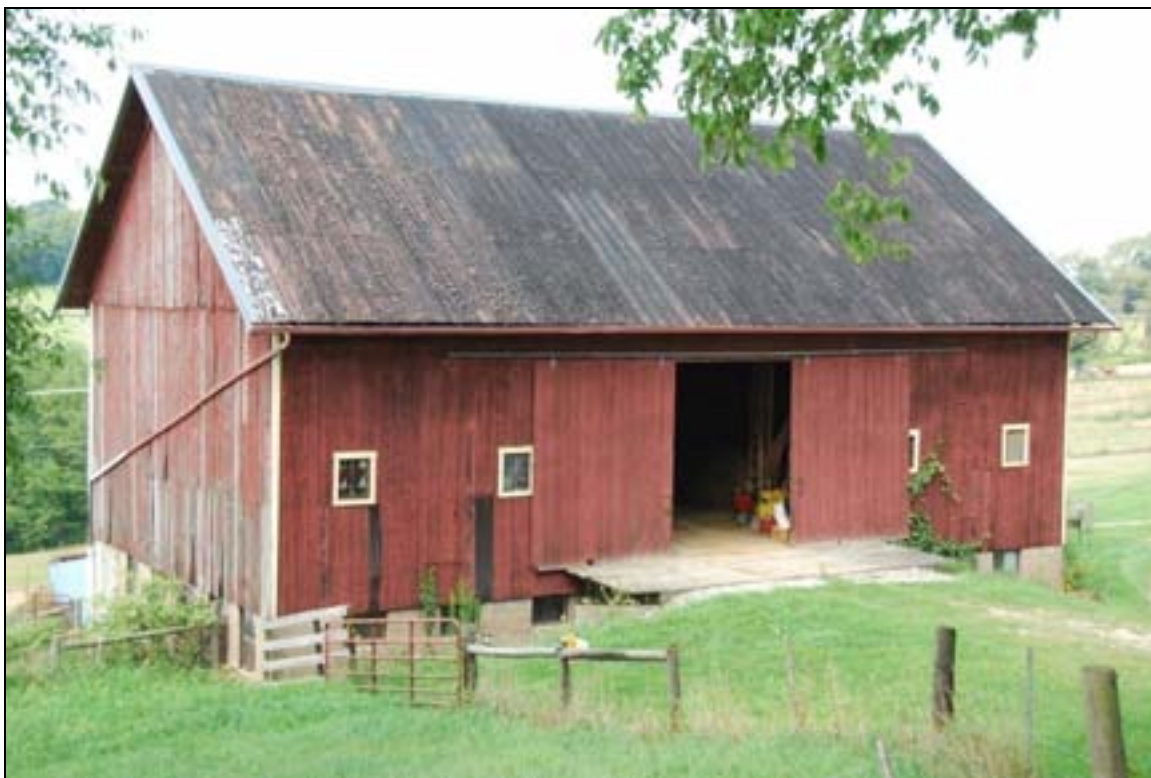
*#802080—1575 S.R. 50 Hwy., Hickory, Mount Pleasant Township, Washington County*

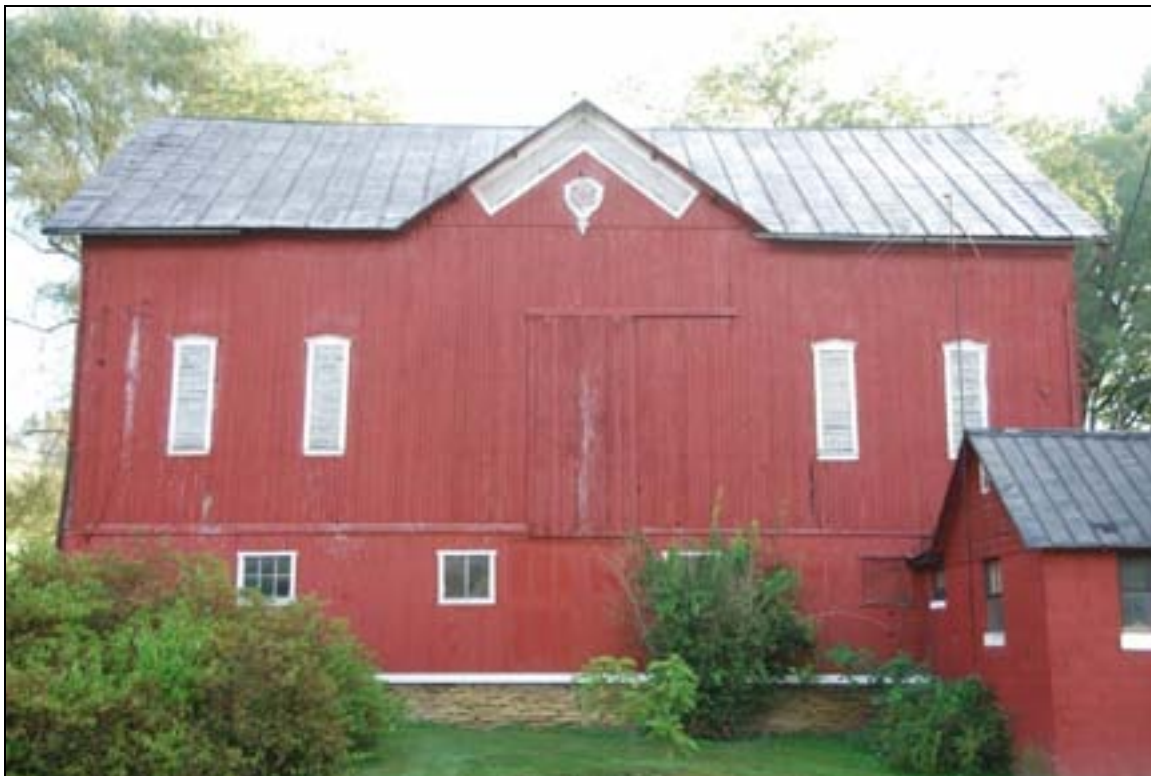
***#802396—622 519 Hwy., Eighty Four, Somerset Township, Washington County***

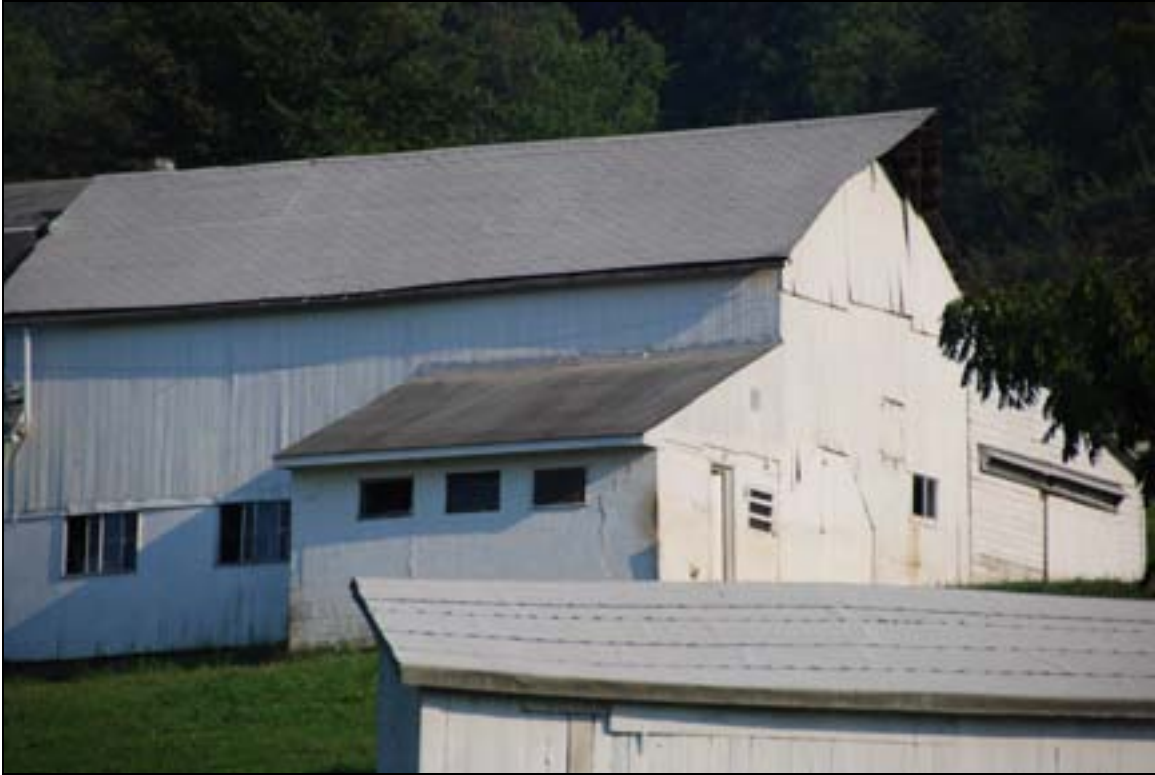
*#802165—649 Cross Creek Rd., Rea, Cross Creek Township, Washington County*

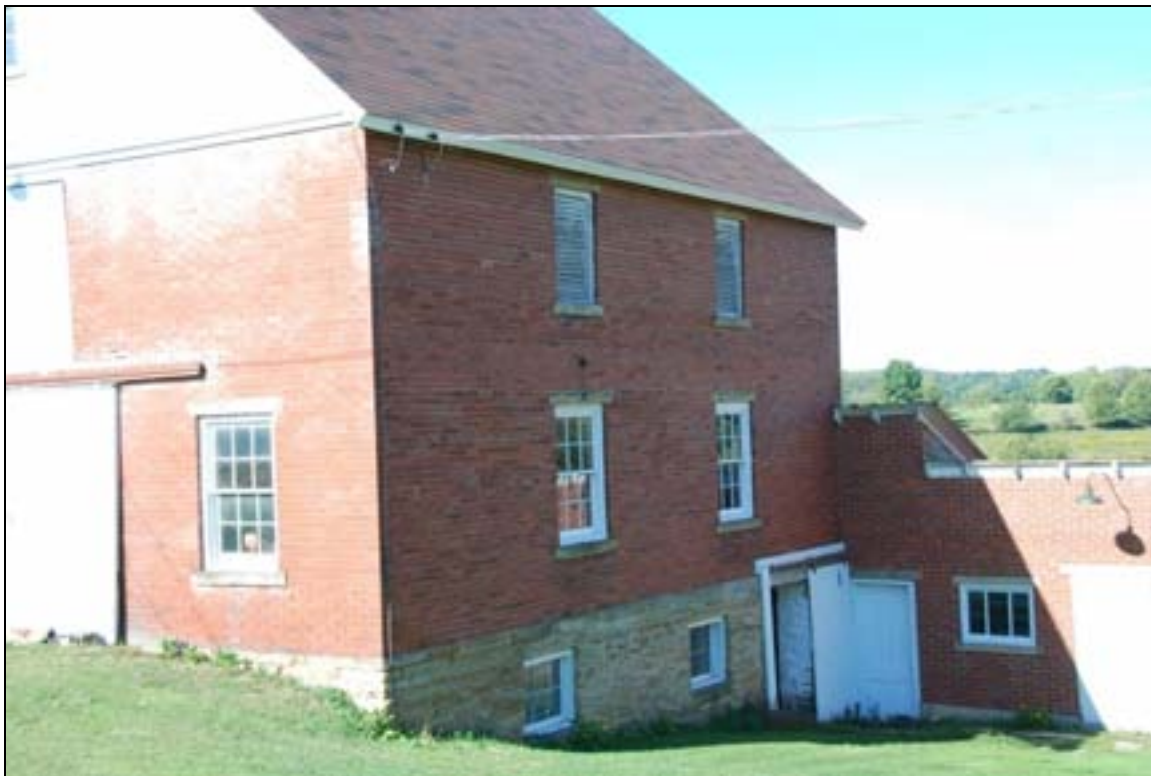
*#802414—262 Caldwell Rd., Eighty Four, Somerset Township, Washington County*

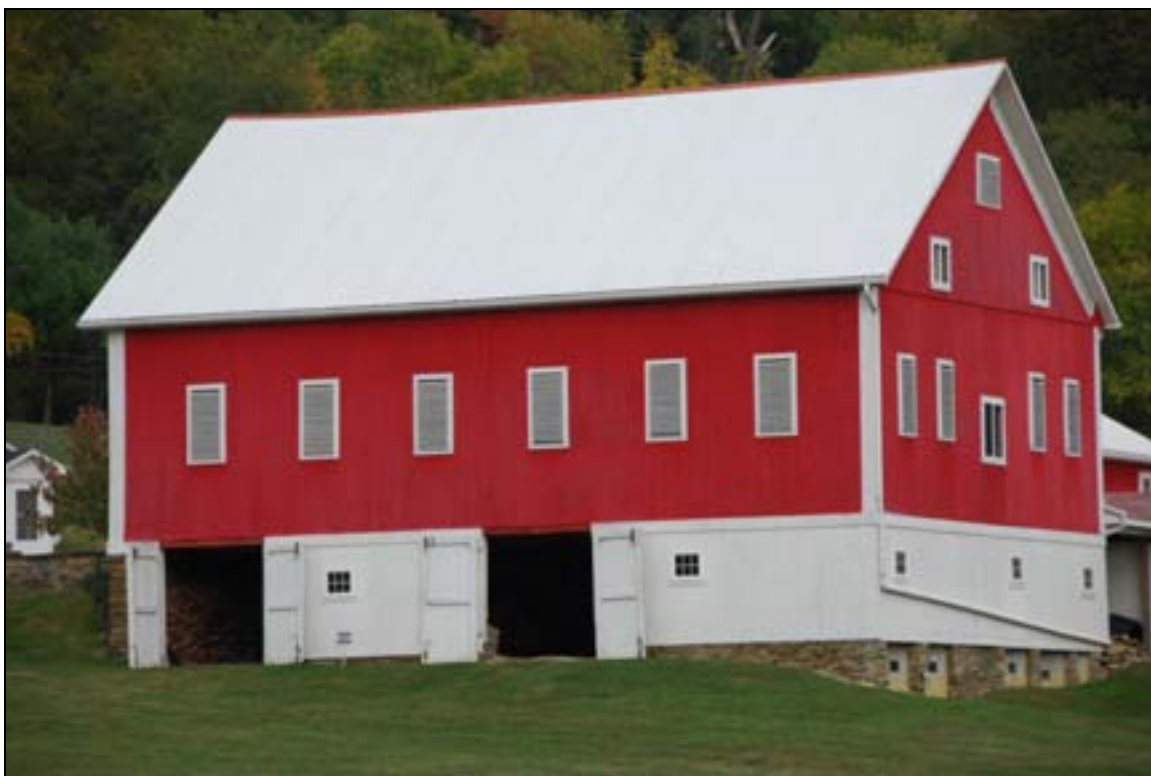
**#802527—460 Smith Run Rd., Amity, Amwell Township, Washington County**

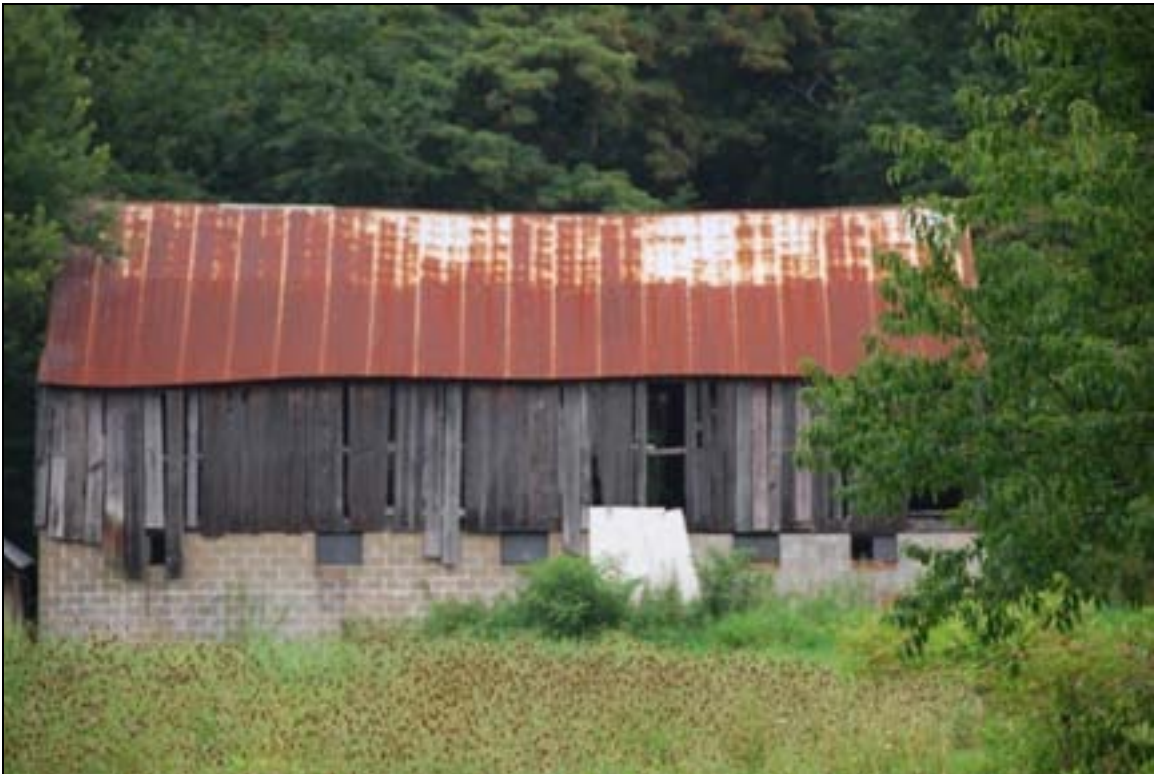
**#802016—Willow Rd. Hickory, Hopewell Township, Washington County**

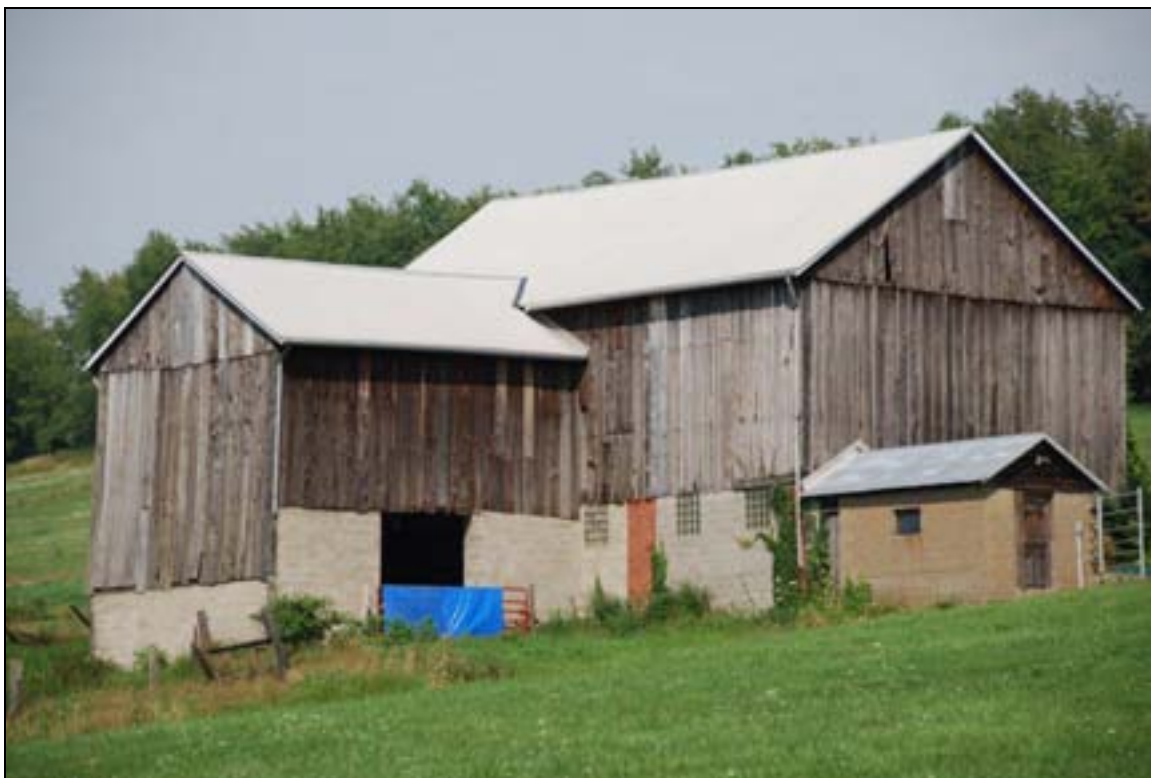
**#802062—O.P. Cooke, 1446 N Rt. 18 Hickory, Smith Township Washington County**

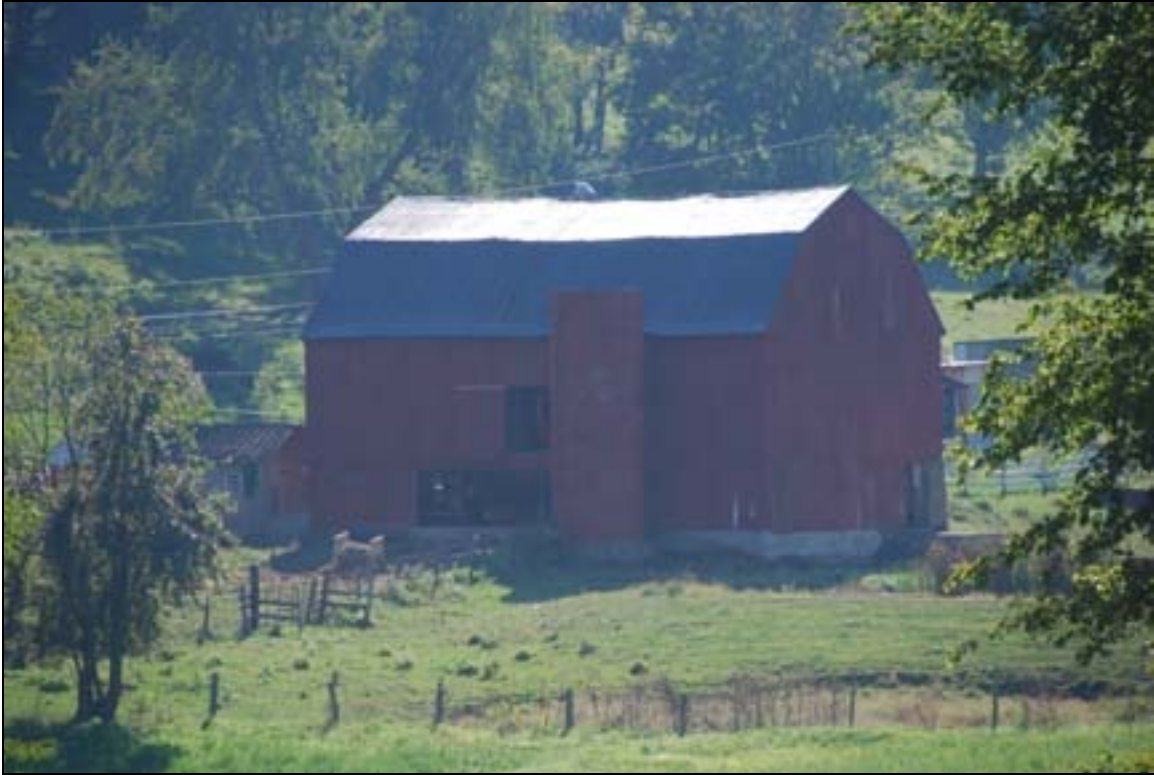
***#802319—30 Weizen Rd., Coal Center, West Pike Run Township, Washington County***

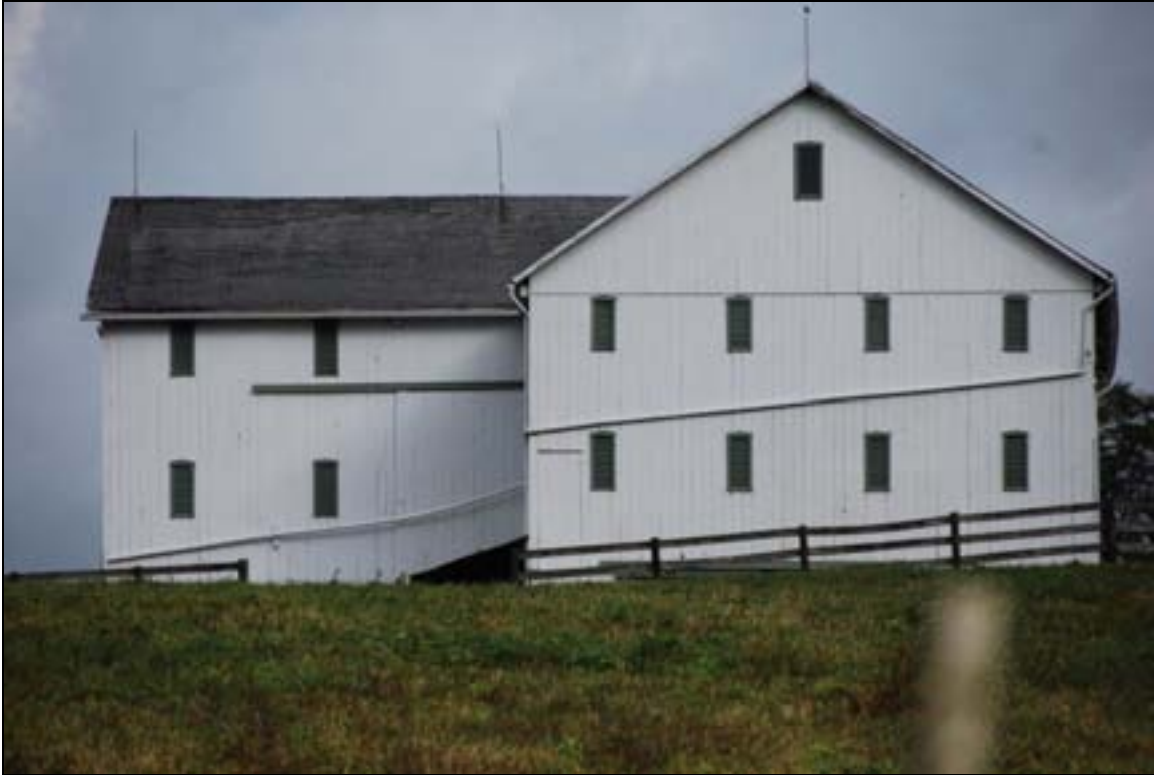
*#802498—20 Hillcrest Lane, Washington, Hopewell Township, Washington County*

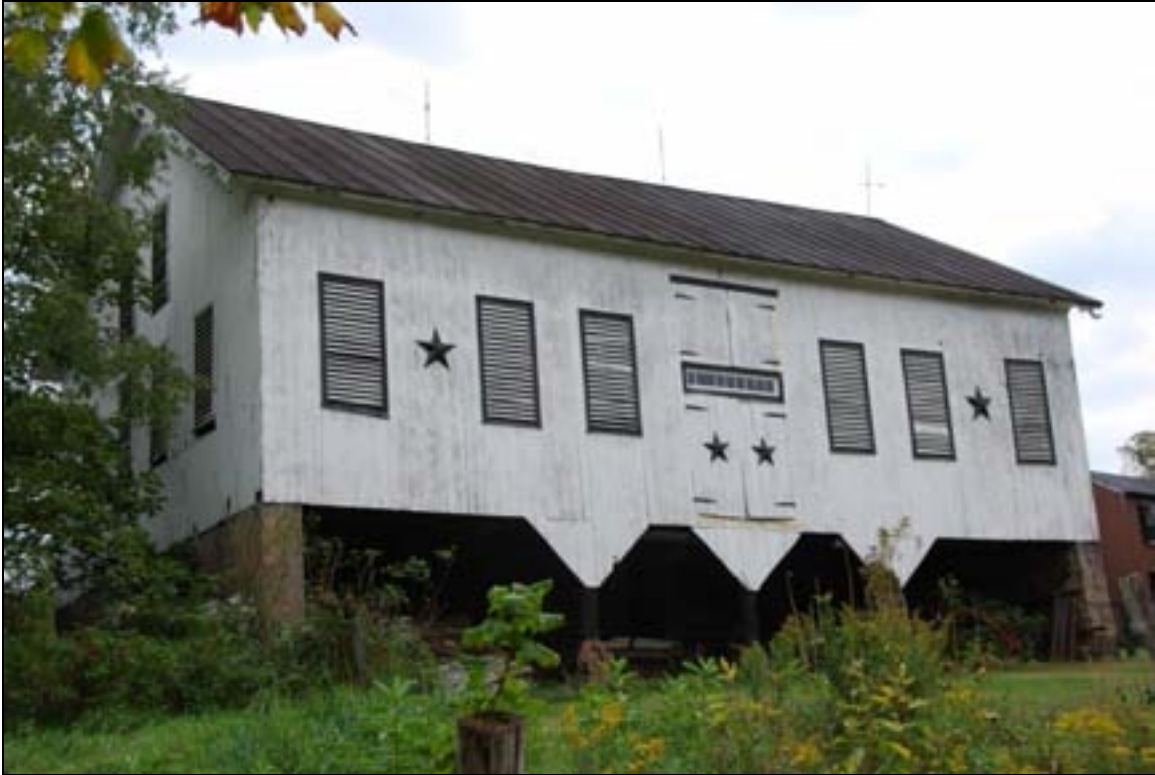
*#802431—610 Daniels Run Rd., Scenery Hill, North Bethlehem Township Washington County*

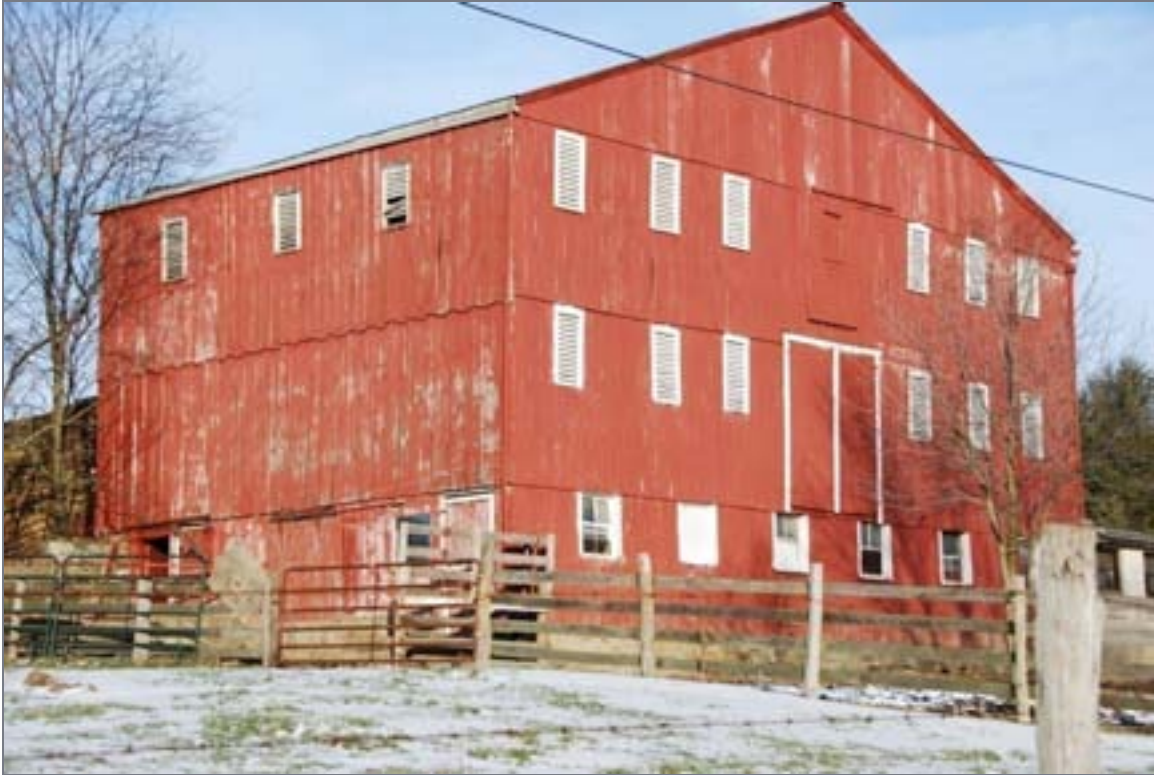
*#802691—601 Valley View Rd., Claysville, East Finley Township Washington County*

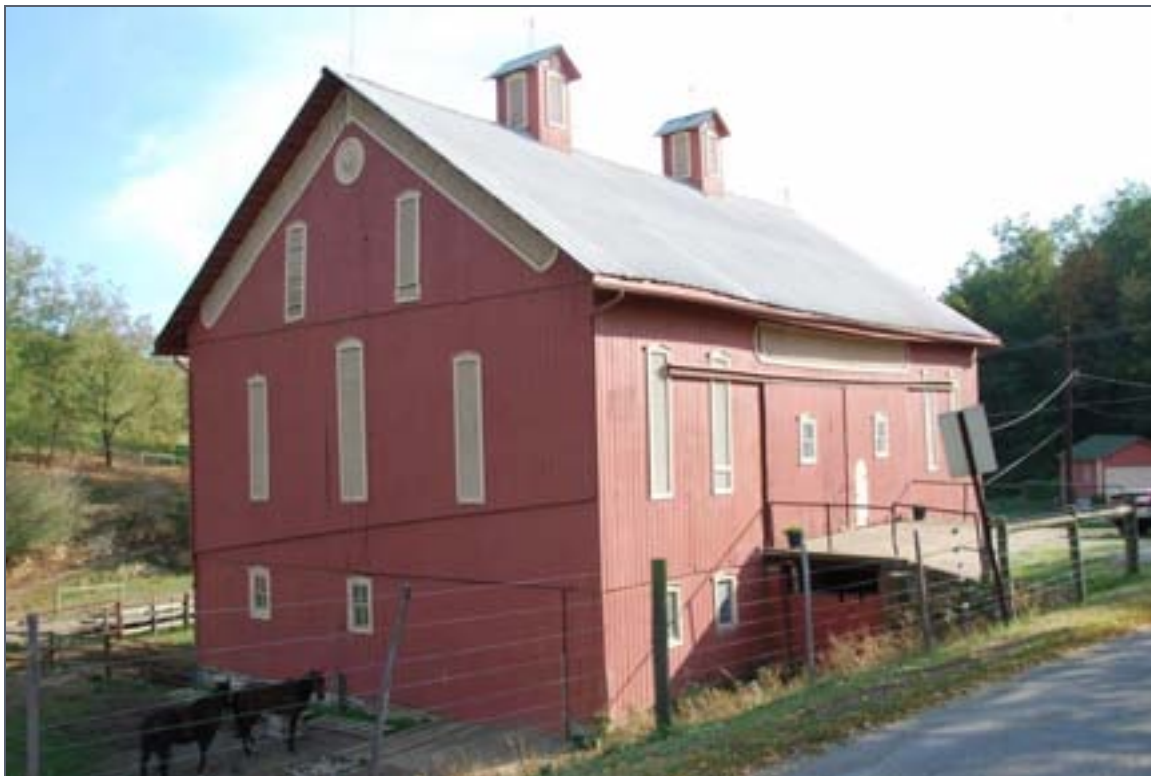
***#802440—Andrew Sundecker; Mong Rd., Scenery Hill, North Bethlehem Township Washington County***

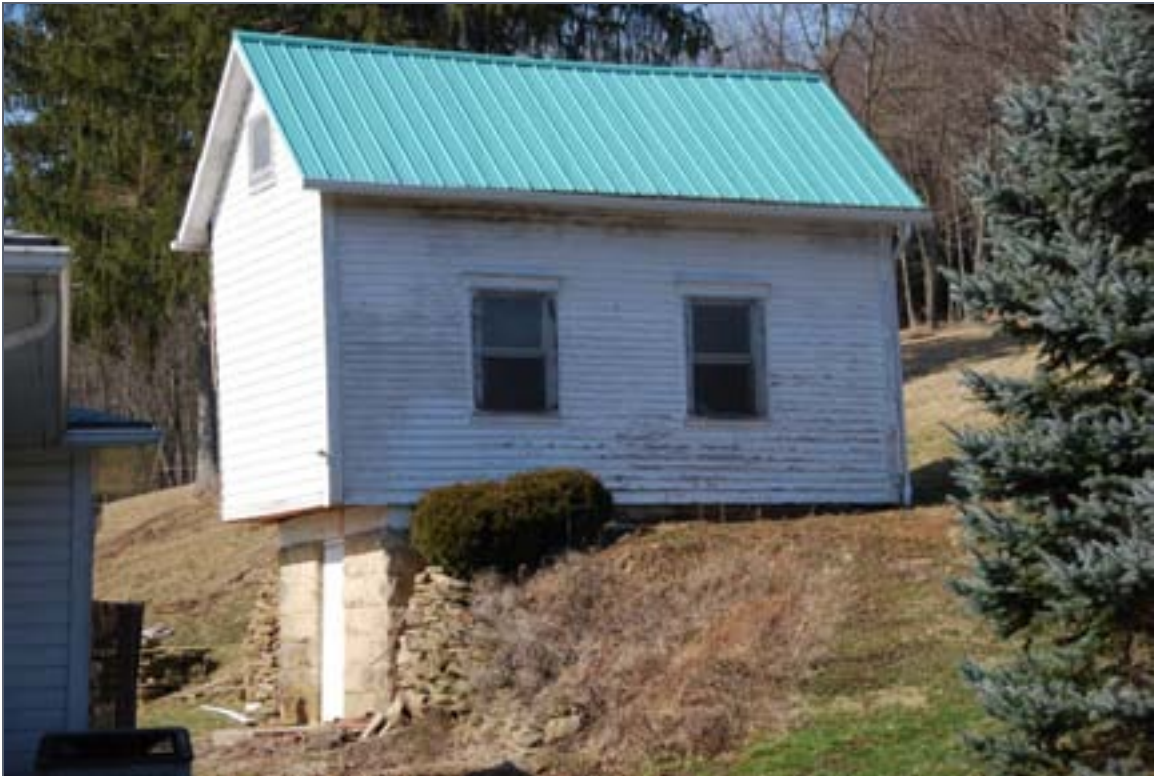
**#803108—487 Pitcock Run Rd., Waynesburg, Whiteley Township Greene County**

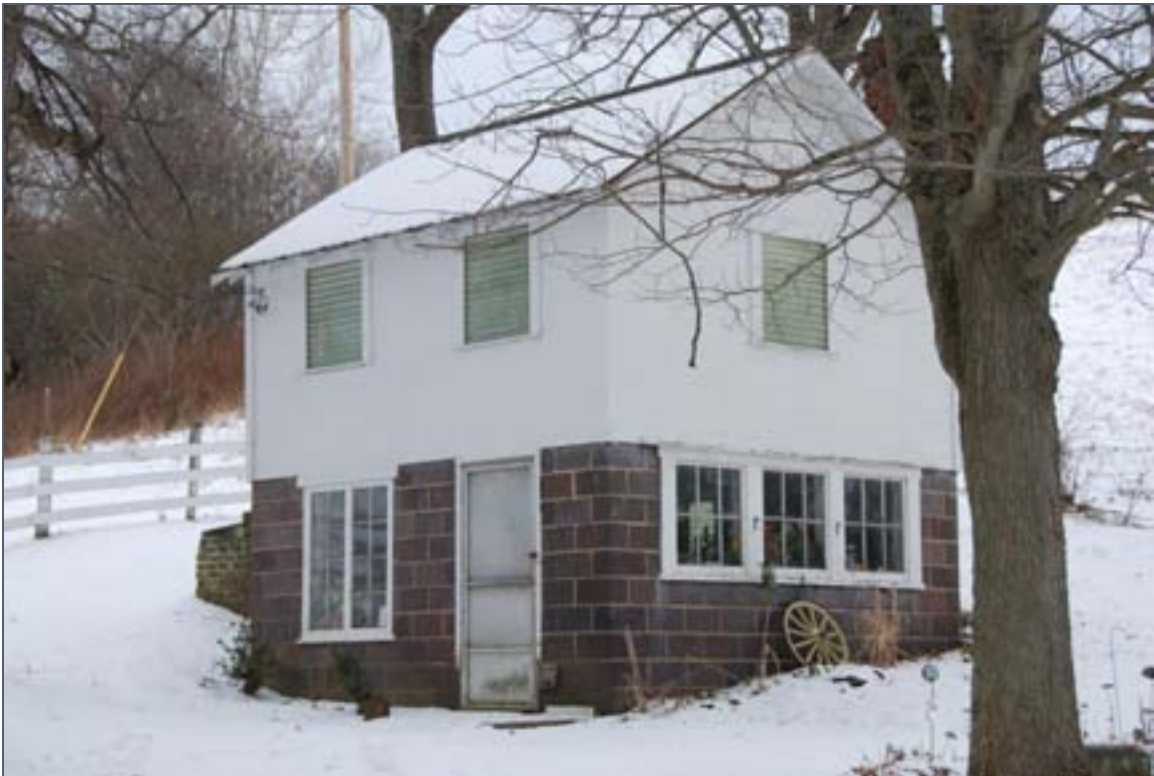
**#802682—238 Walnut Valley Rd., West Alexander, West Finley Township Washington County**

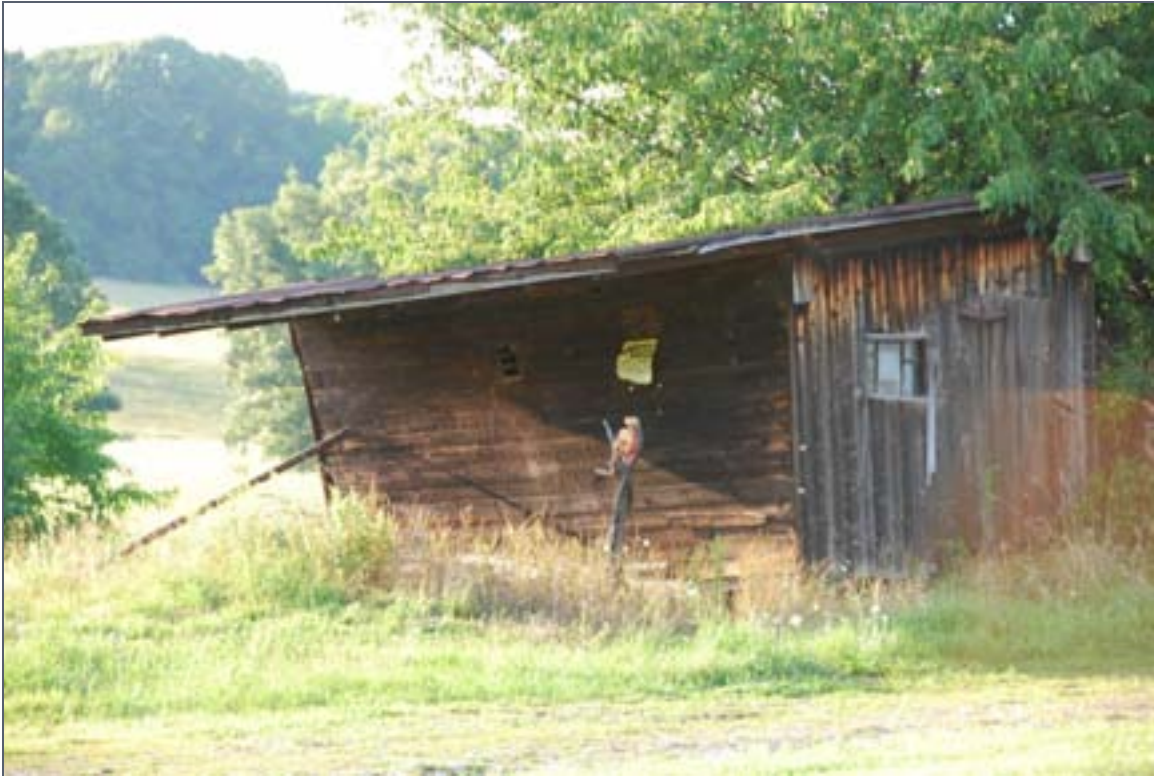
*#802069—26 Covered Bridge Rd., Burgettstown, Smith Township Washington County*

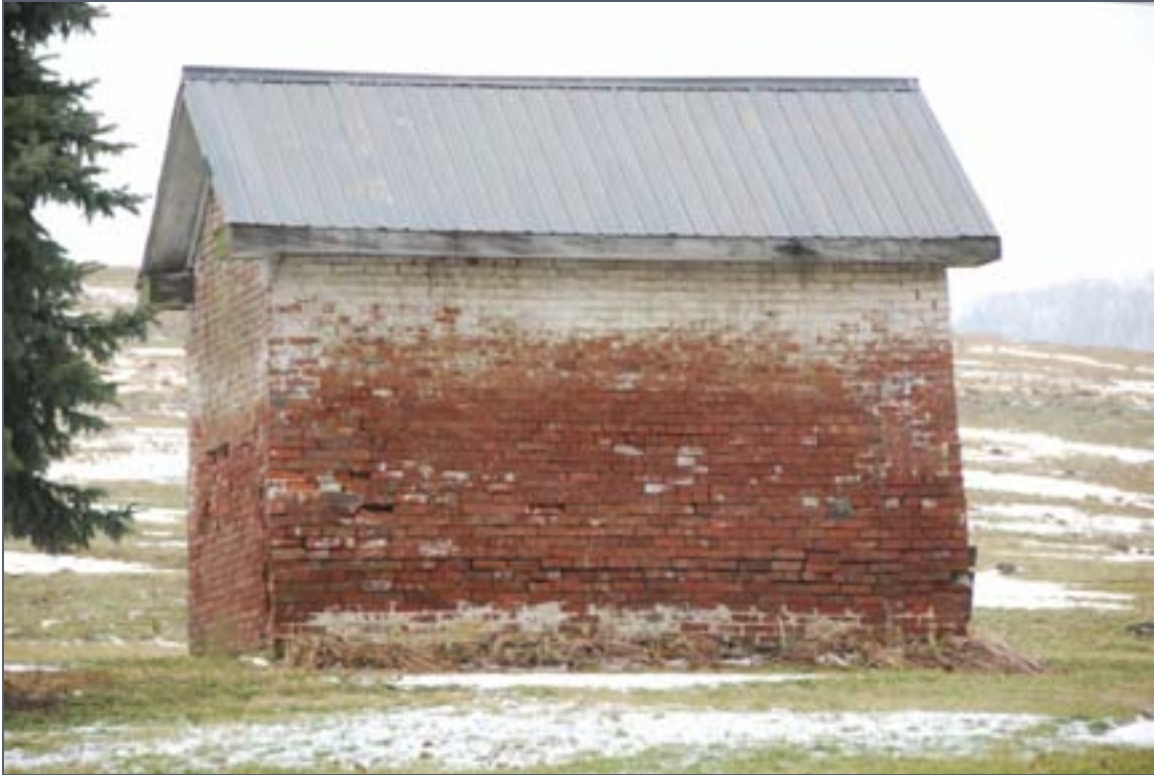
*#803088—Ceylon Rd., Carmichaels, Greene Township Greene County*

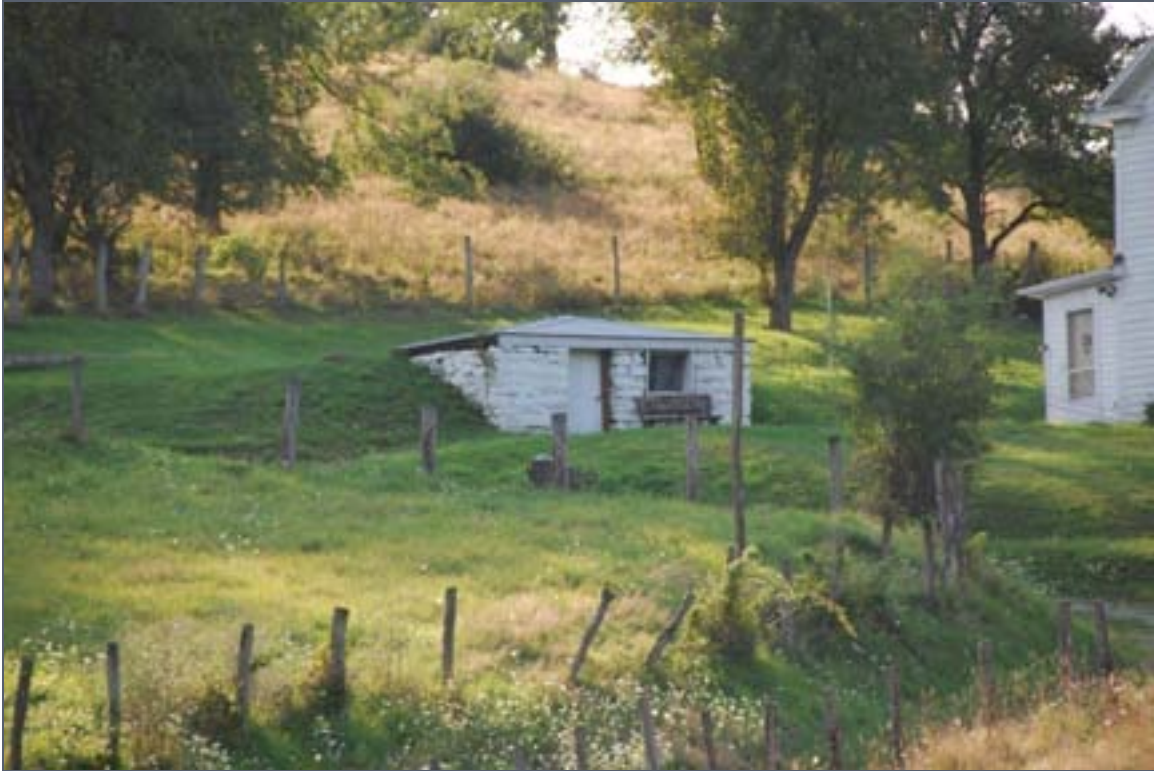
***#802118—301 Garvin Rd., Finleyville, Union Township Washington County***
