# HISTORIC AGRICULTURAL SURVEY REPORT

*Washington & Greene Counties, Pennsylvania  
2007-2008*

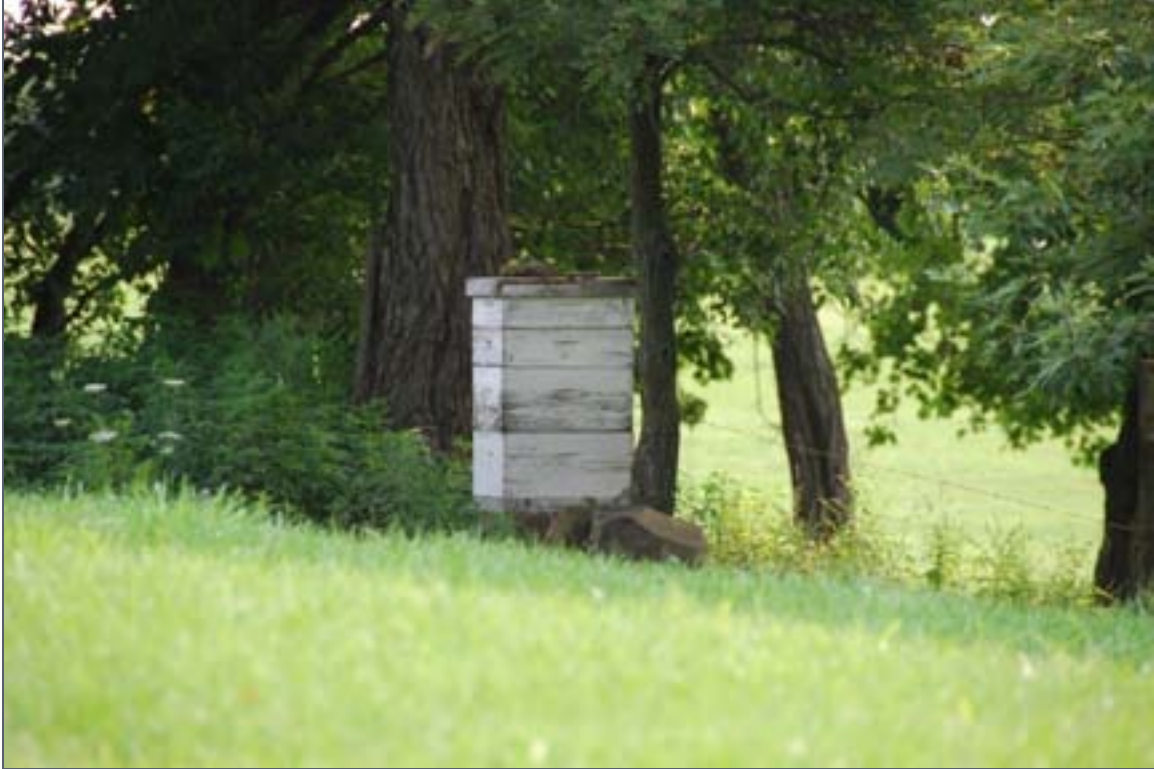
*#802053—219 Point Pleasant Rd., McDonald, Smith Township Washington County*

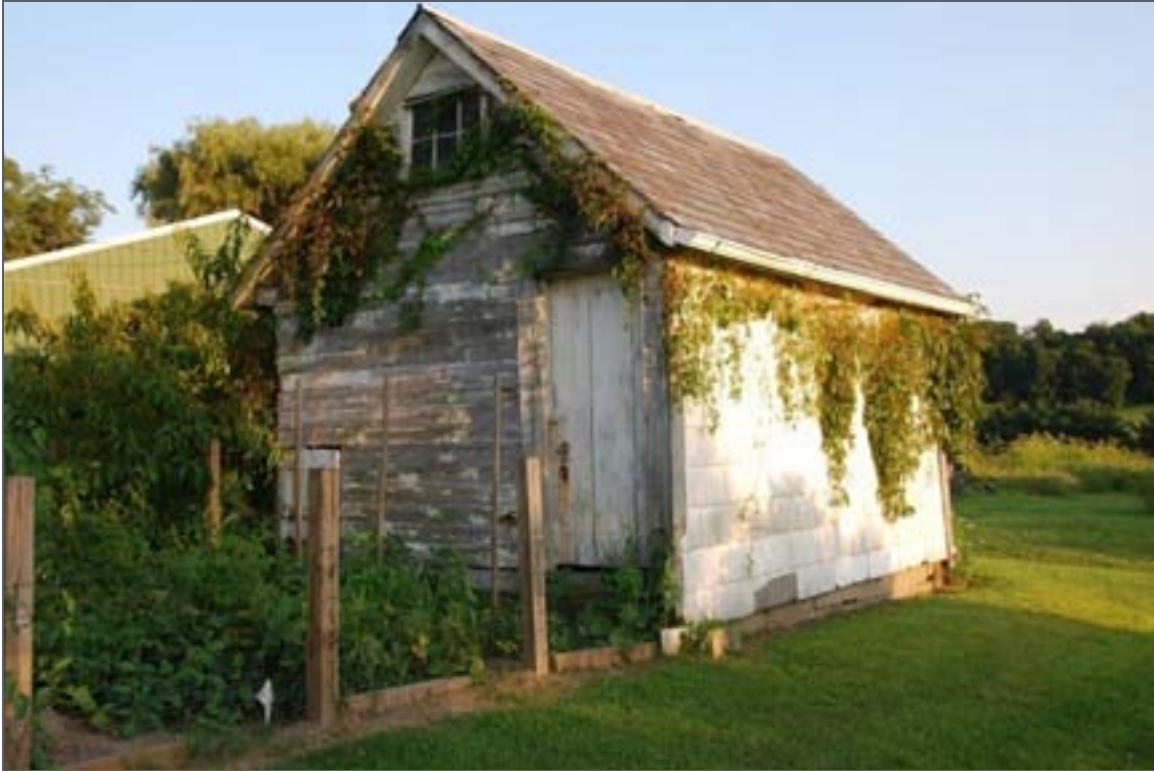
***#802070—1293 Ridge Rd., Burgettstown, Smith Township Washington County***

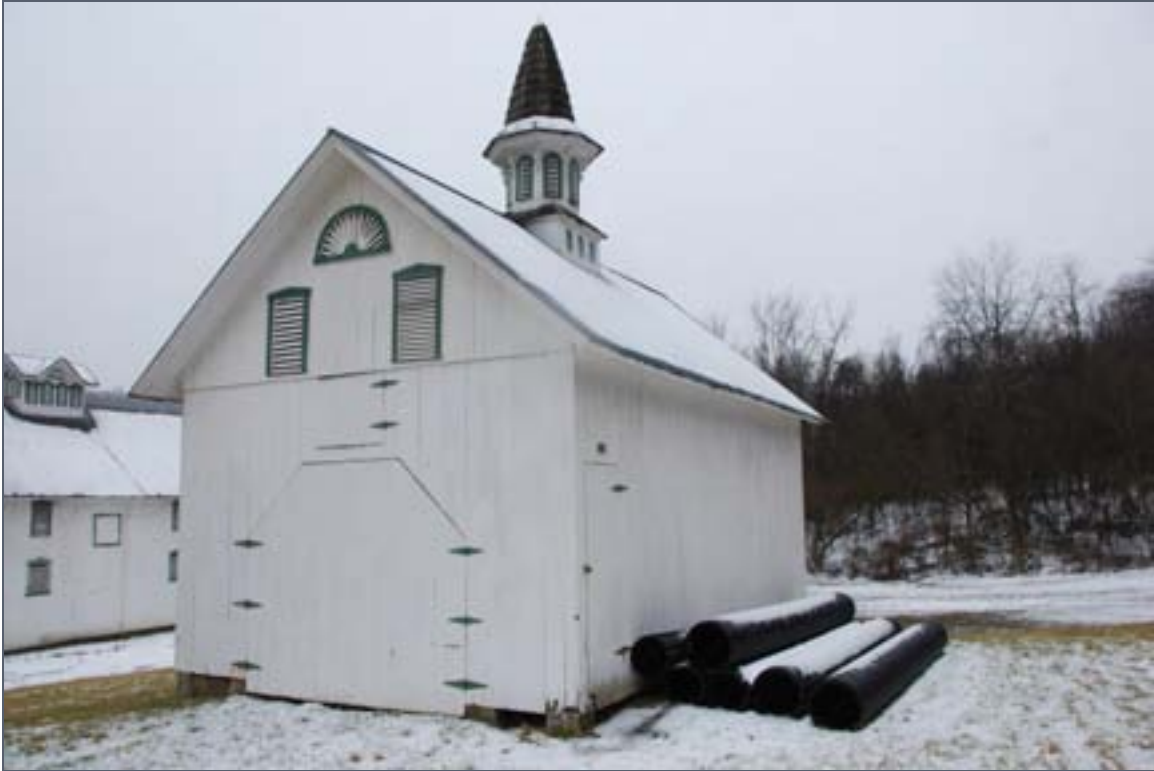
**#803082—Garards Fort Rd., Waynesburg, Greene Township Greene County**

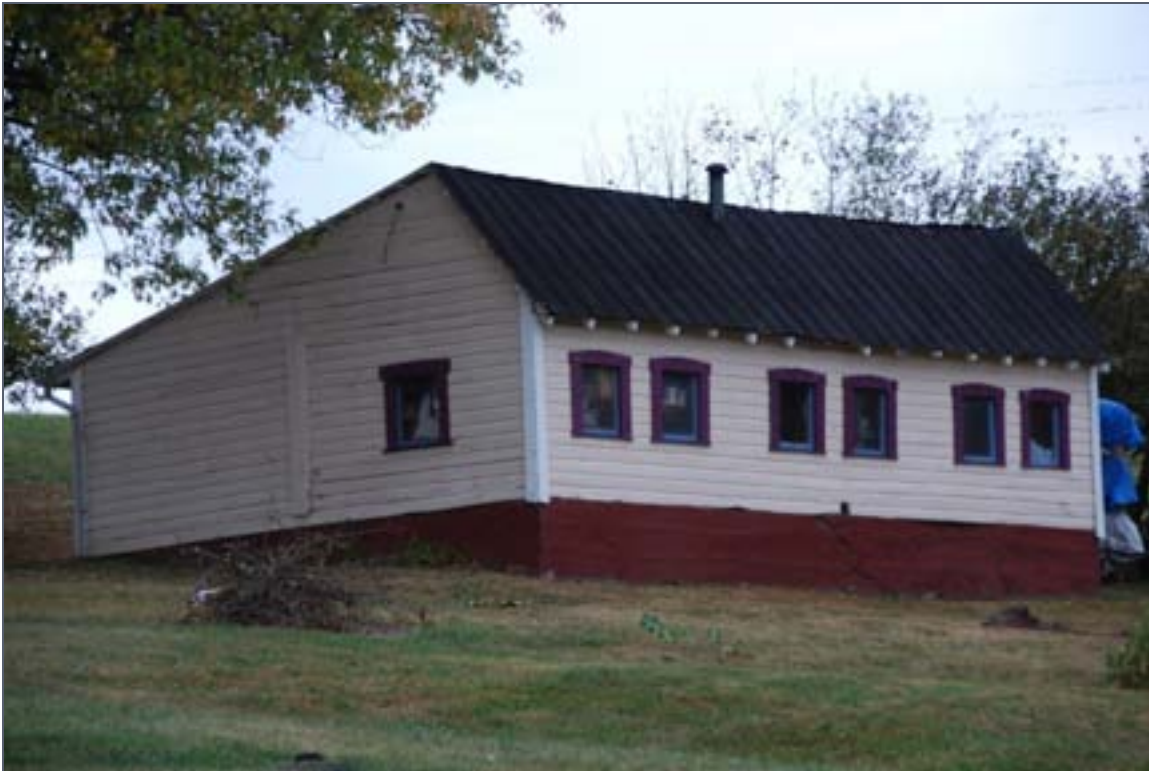
***#802552—940 Mounts Valley Rd., Washington, Buffalo Township Washington County***

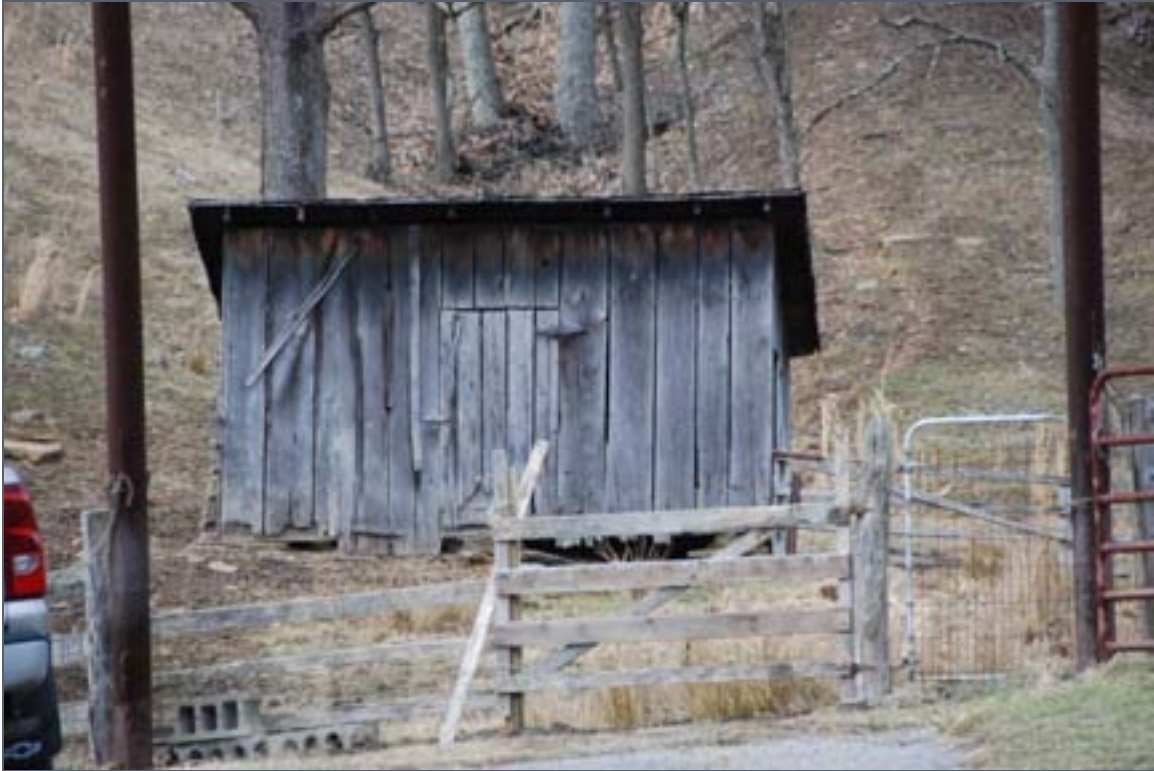
*#803148—403 Church Run Rd., Mount Morris, Perry Township Greene County*

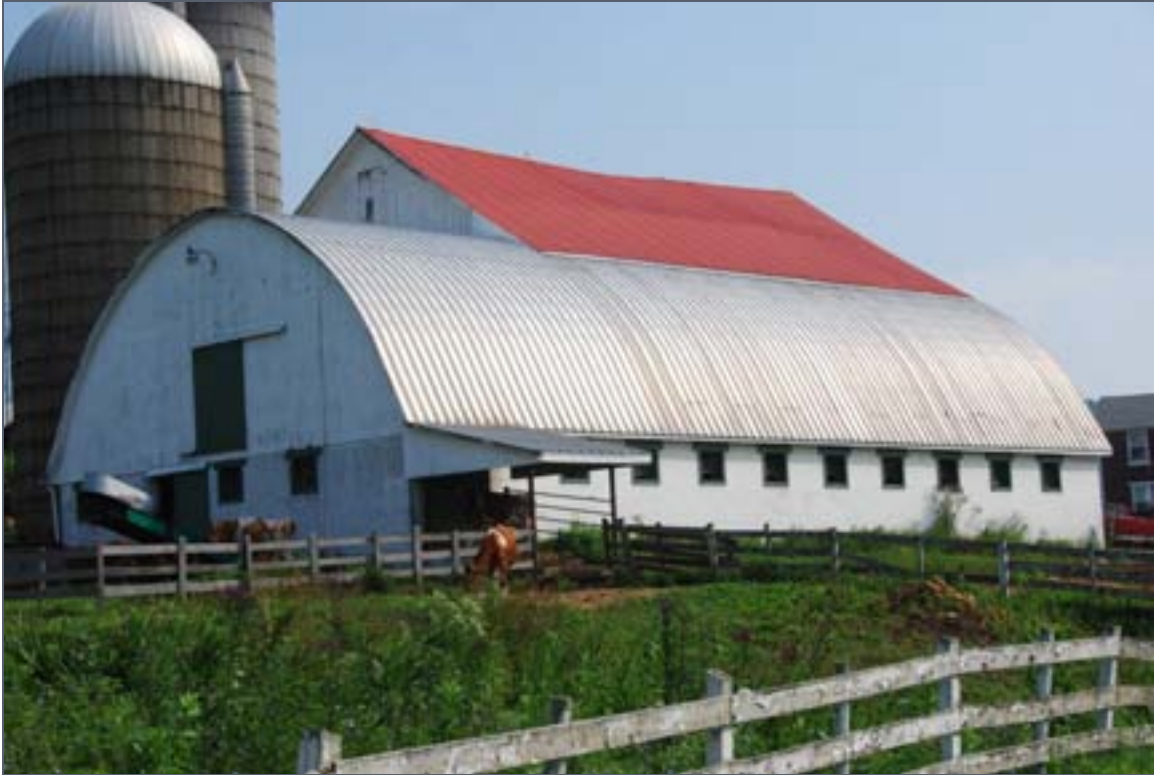
*#802014—160 Dairy Rd., Hickory, Mount Pleasant Township Washington County*

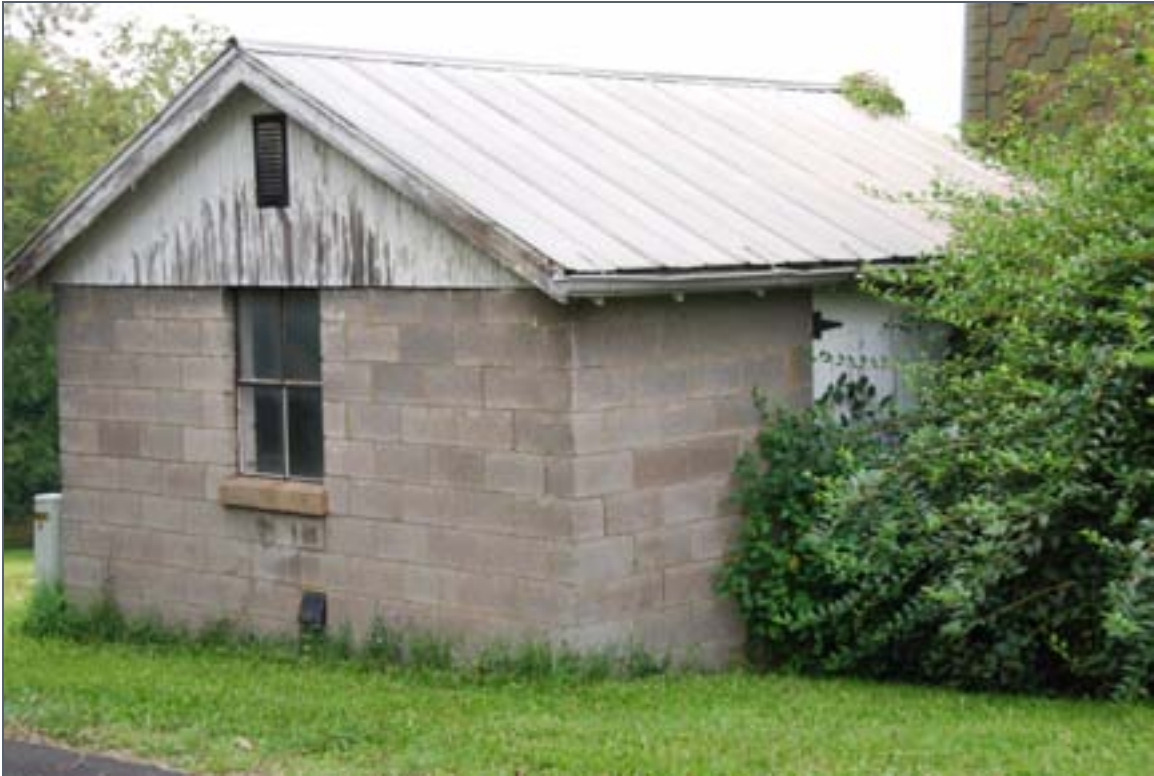
*#802083—14 Johnston Rd., McDonald, Mount Pleasant Township Washington County*

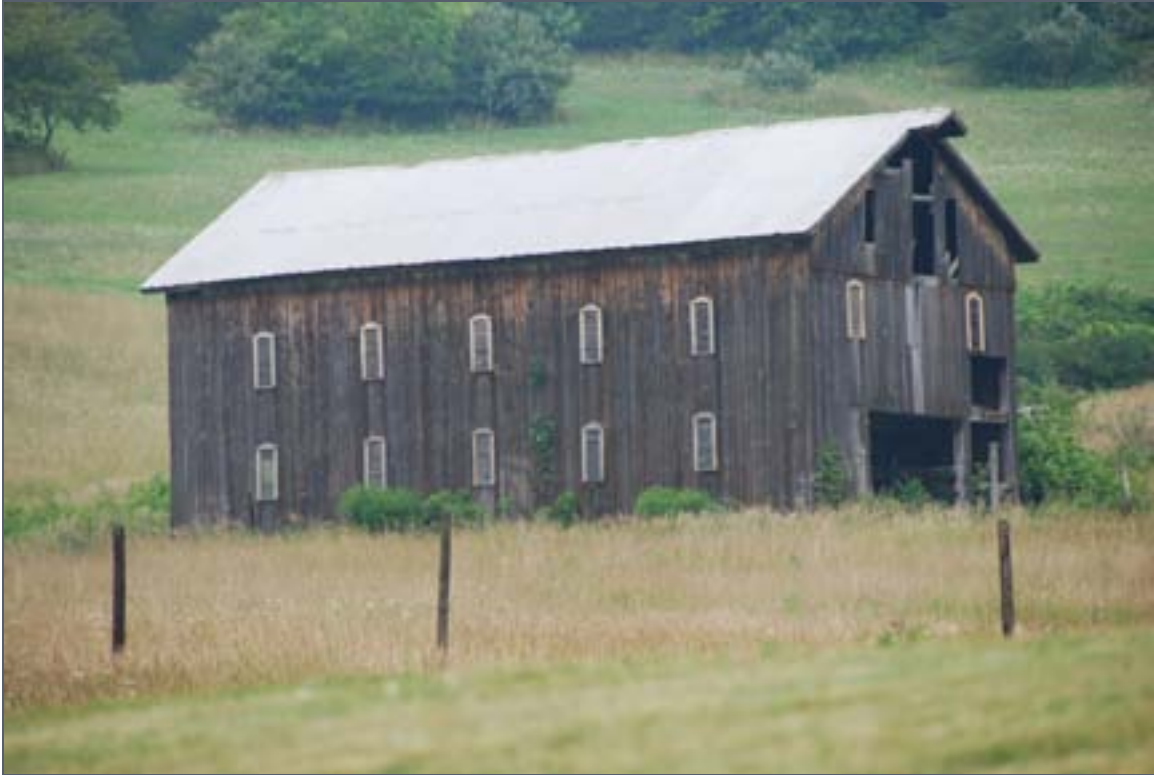
*#802009—230 McConnell Rd., Hickory, Mount Pleasant Township Washington County*

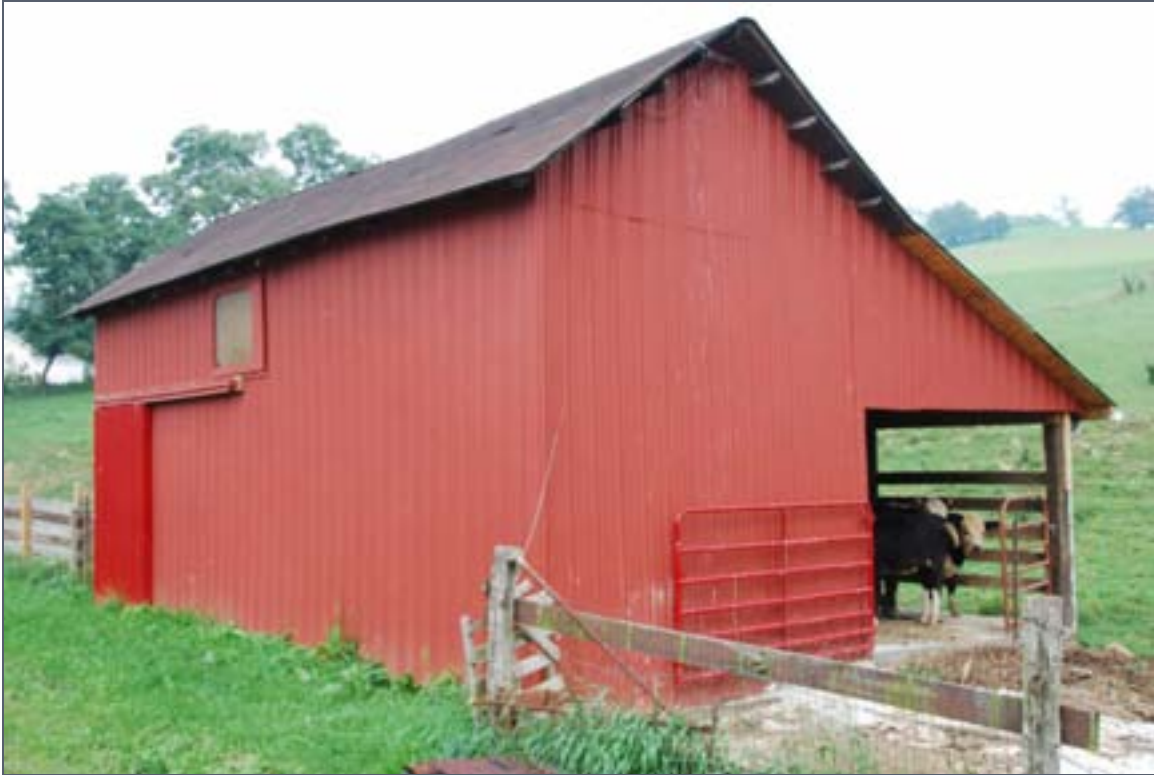
*#802010—123 Beechnut Rd., Hickory, Mount Pleasant Township Washington County*

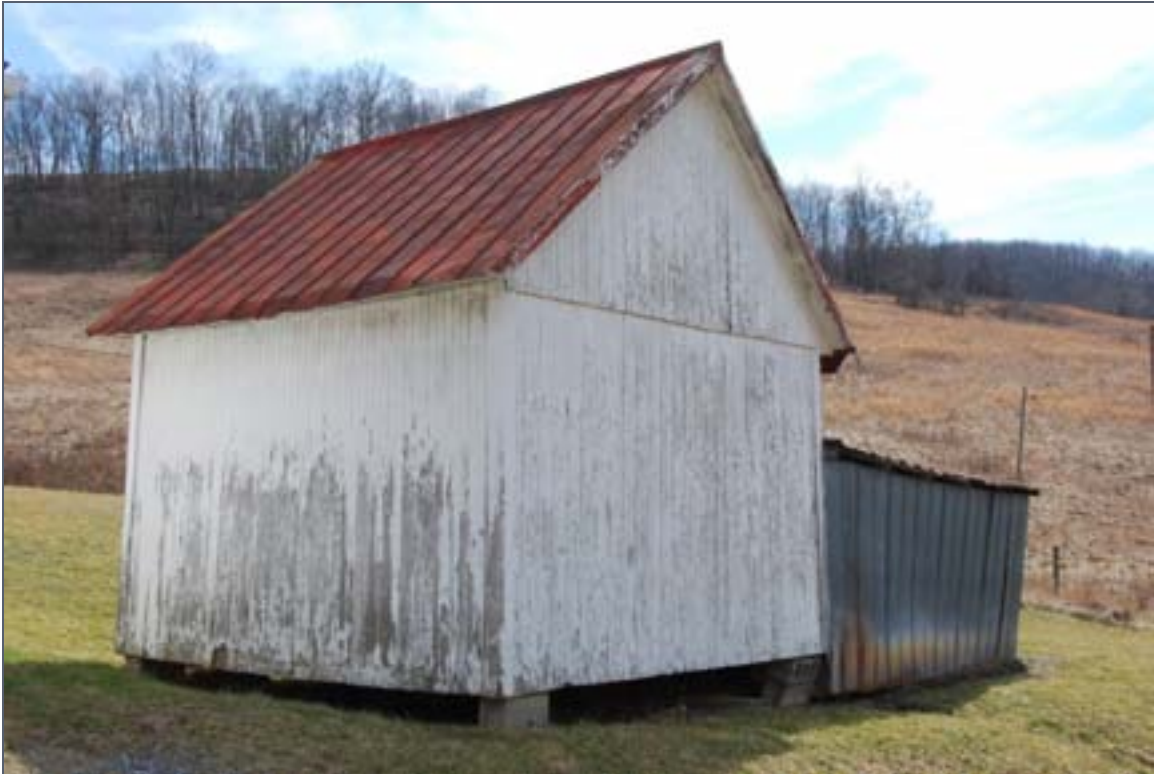
*#803139—330 Dairy Farm Rd., Mount Morris, Perry Township Greene County*

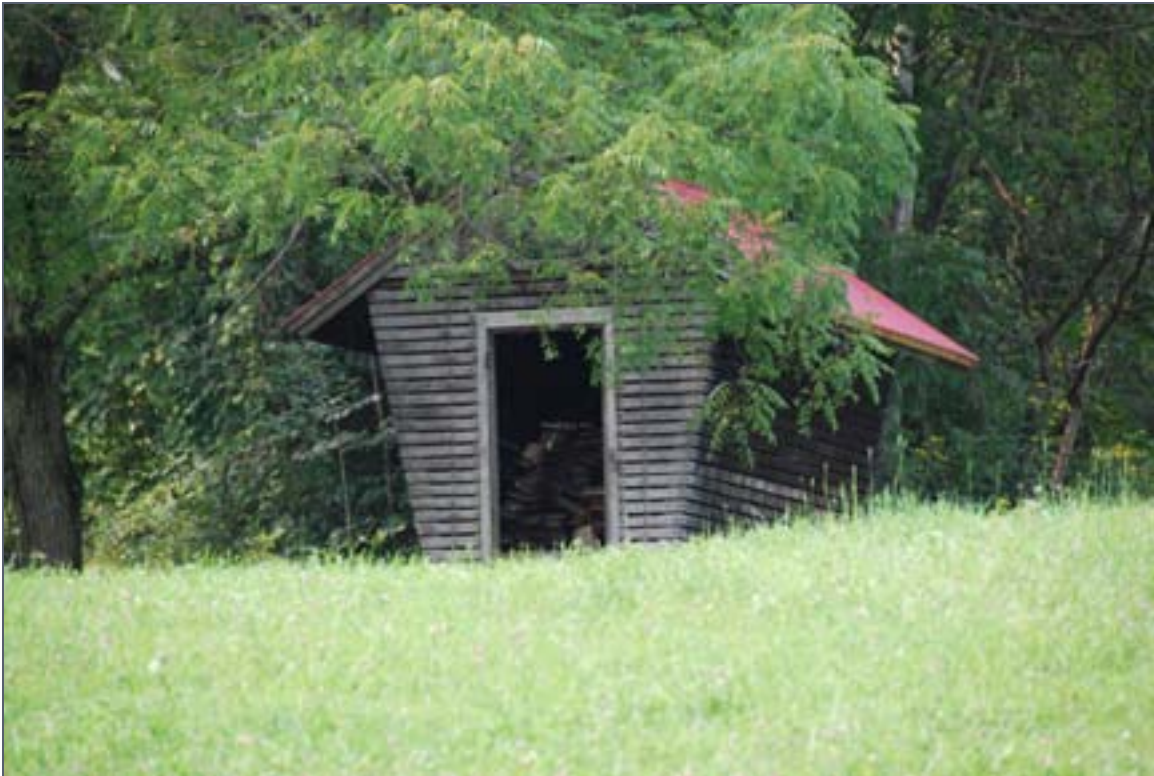
**#802093—2194 Reisling Rd., McDonald, Cecil Township, Washington County**

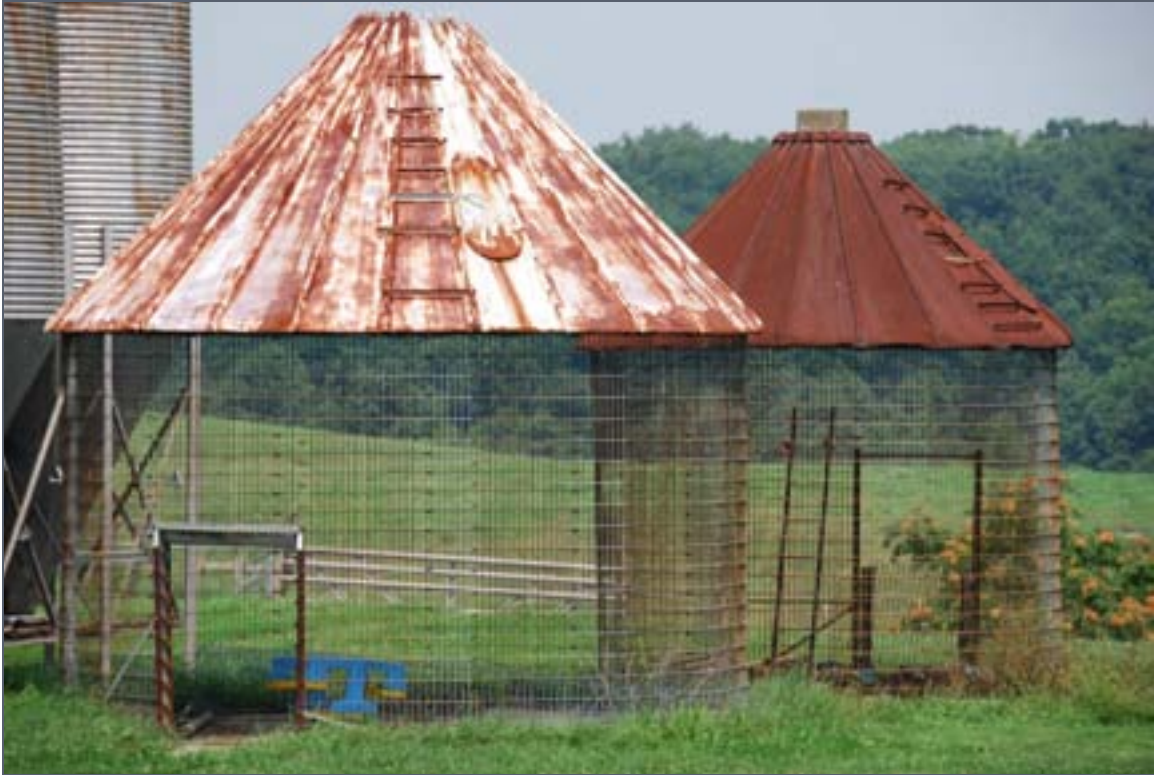
*#802030—901 Purdy Rd., Burgettstown, Hanover Township Washington County*

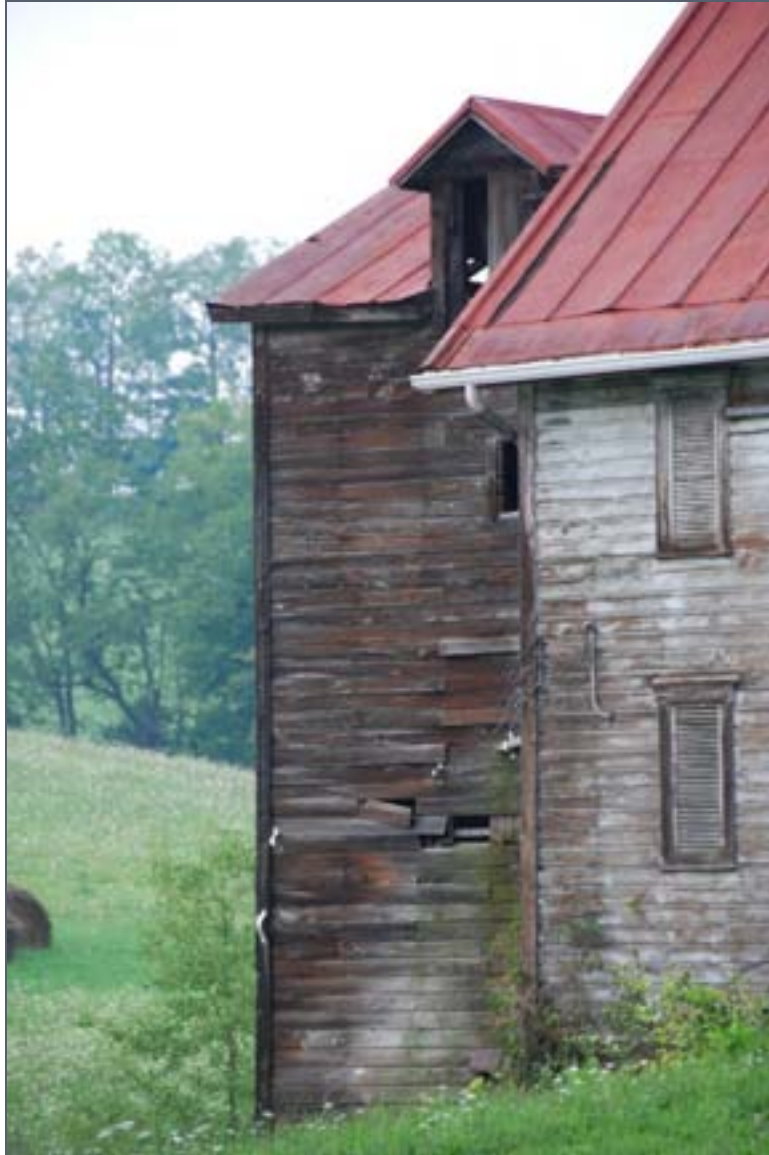
*#802099—Muse Bishop Rd., Canonsburg, Cecil Township Washington County*

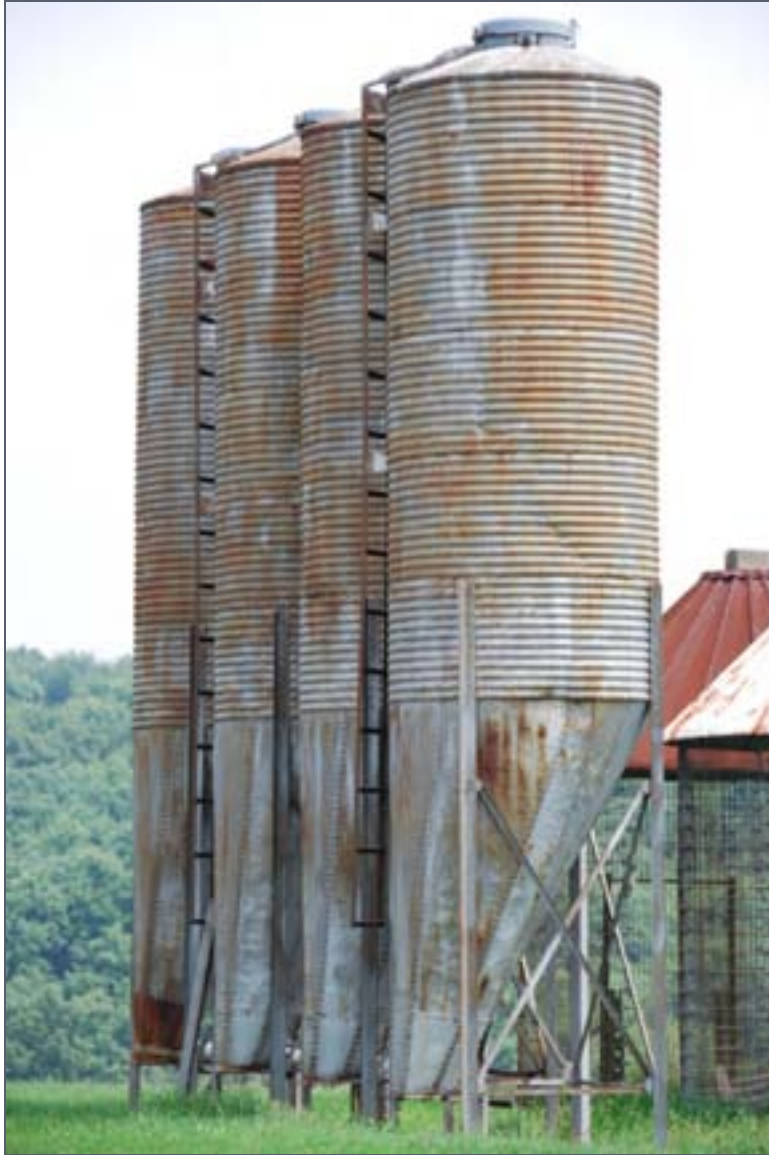
*#802030—901 Purdy Road, Burgettstown, Hanover Township Washington County*

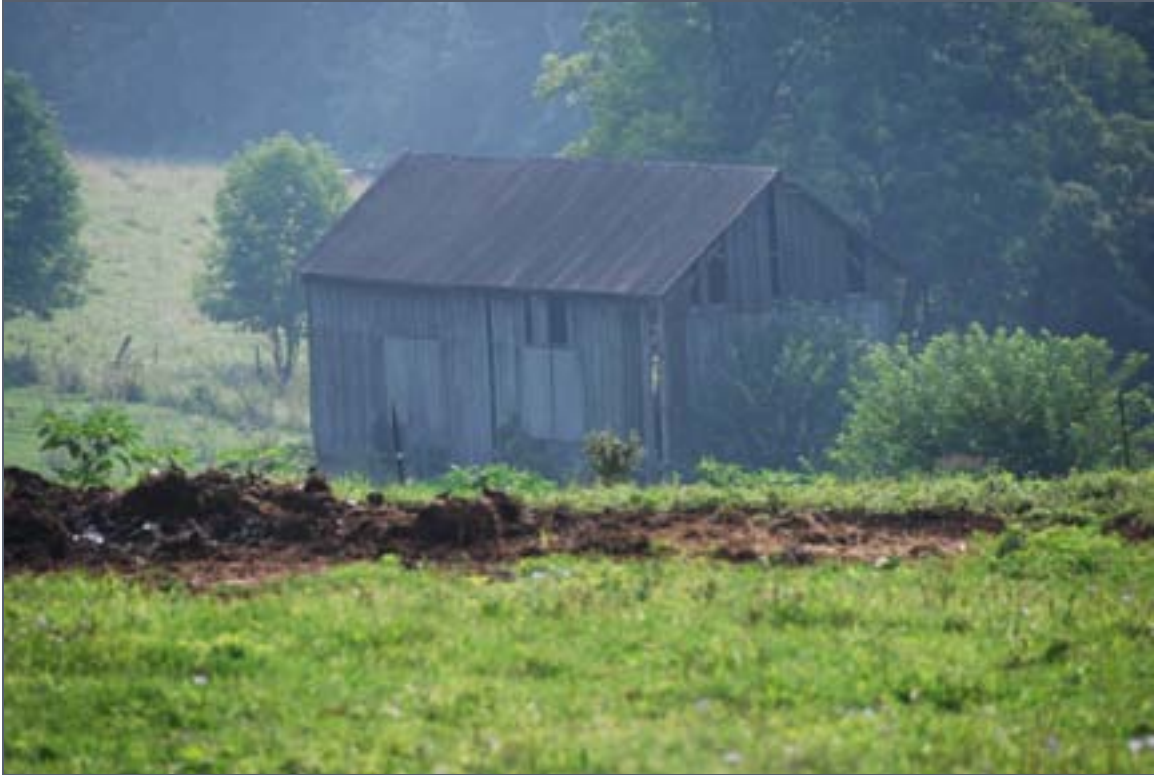
*#802013—40 Dairy Rd., Hickory, Mount Pleasant Township Washington County*

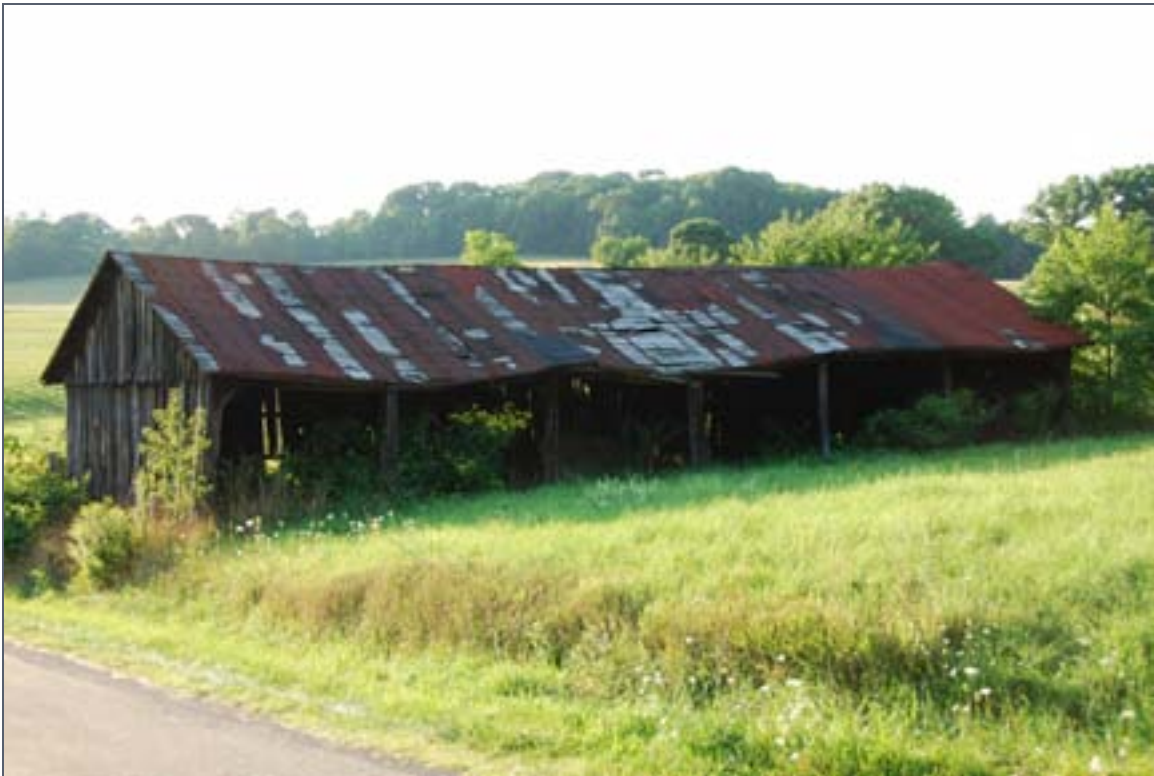
**#802069—26 Covered Bridge Rd., Burgettstown, Smith Township Washington County**

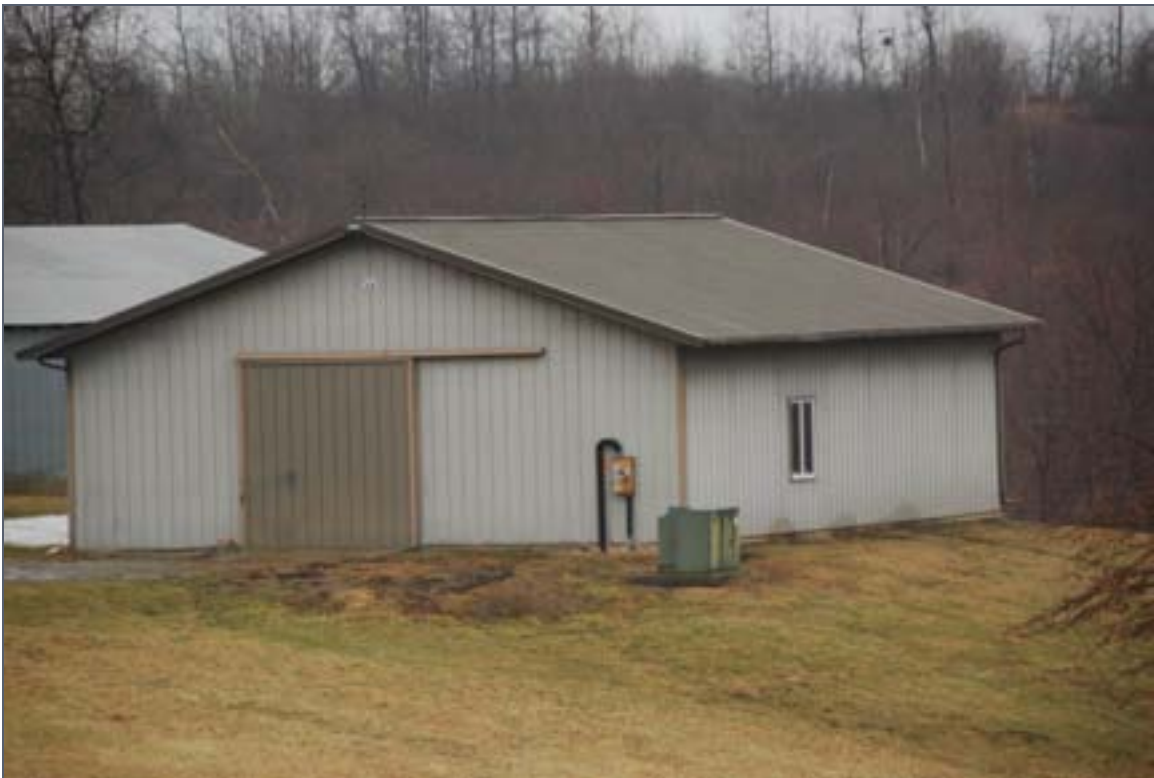
**#803059—136 Colvin Rd., Greensboro, Monongahela Township Greene County**

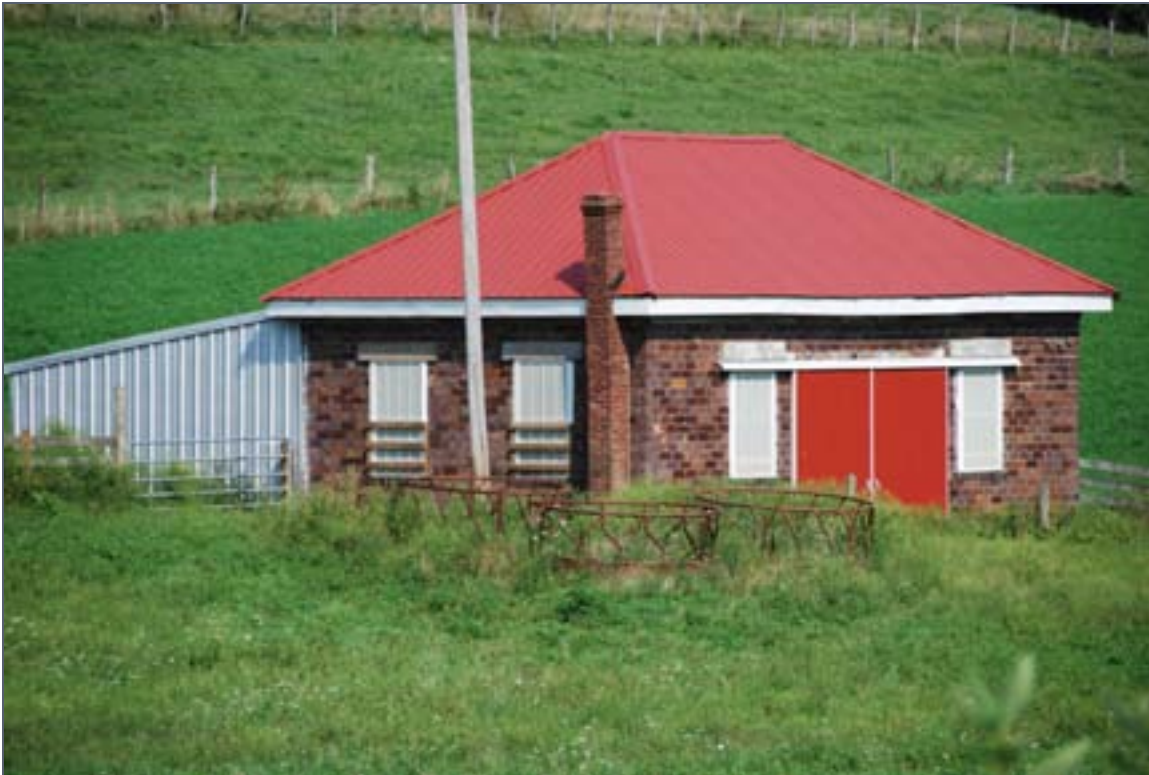
*#802130—214 Cedar Grove Rd., Avella, Jefferson Township Washington County*
