GROVE CITY
COLLEGE

PRESERVATION PLAN

GROVE CITY COLLEGE HISTORIC CAMPUS PRESERVATION PLAN

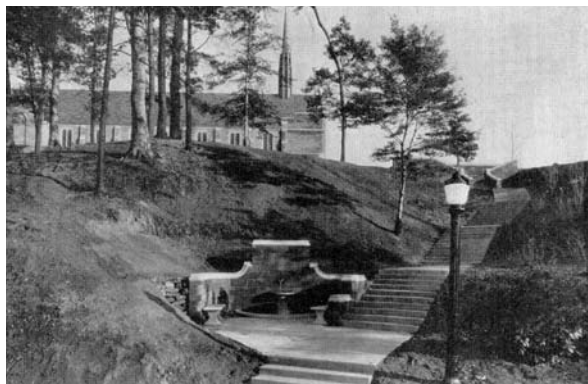
Looking toward campus from historic ravine. Harbison Chapel in background.

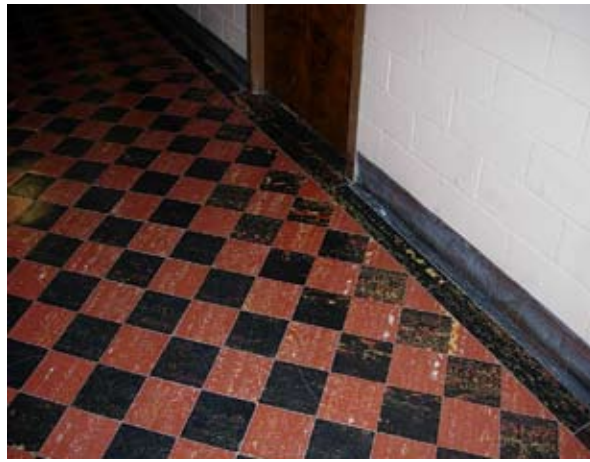
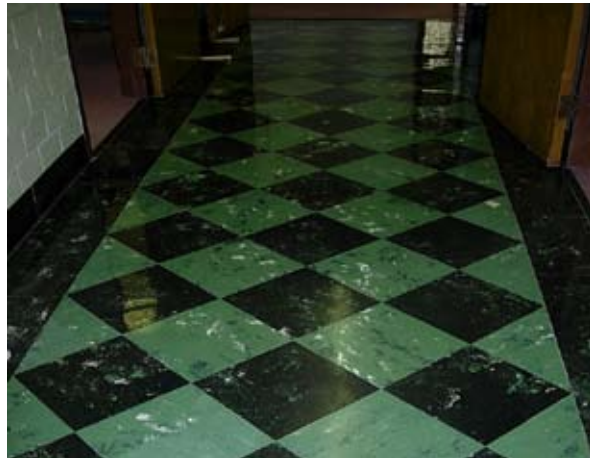
Tile Flooring: Exceptionally colorful patterns of vinyl or possible “zenitherm” flooring were in evidence within many of the buildings, especially Crawford, Mary Anderson Pew, Ketler, Lincoln and Hopeman. Vinyl tile flooring would have been a relatively new building product in the 1930s and 1940s. The colors chosen are strikingly bold, perhaps intended to evoke the rich colors seen in more expensive marble floors. These designs, while using modest building materials, are unique to Grove City College. We realize that wholesale restoration of this historic flooring is not practical given long-term maintenance and possible asbestos containing materials (ACM) issues, however, we recommend retaining portions in key areas where possible. Historic drawings refer to “zenitherm” which was a composite product meant to imitate stone. It is possible some of this highly colored flooring in Mary Anderson Pew or Crawford may be the historic product rather than vinyl.

Vinyl-tile floor covering

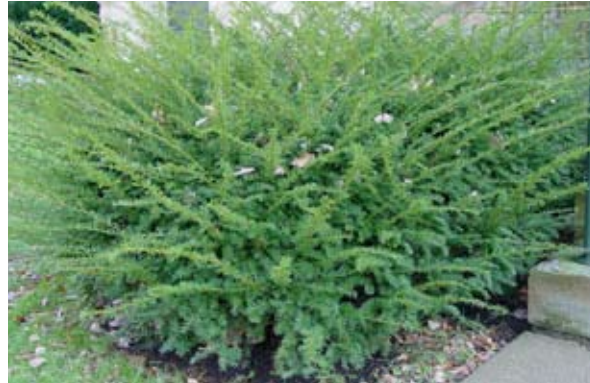
Pruning: The majority of shrub plantings are overly manicured and improperly pruned. It is recommended that shearing of shrubs be discontinued and that hand pruning and thinning be utilized instead to retain a plant's natural growth habit. A maintenance program of pruning of campus and street trees should be considered every two to three years to be implemented either by the grounds crew or by a professional company.

Example of a Yew that is allowed to grow unencumbered in its natural shape. Prune, don't shear.

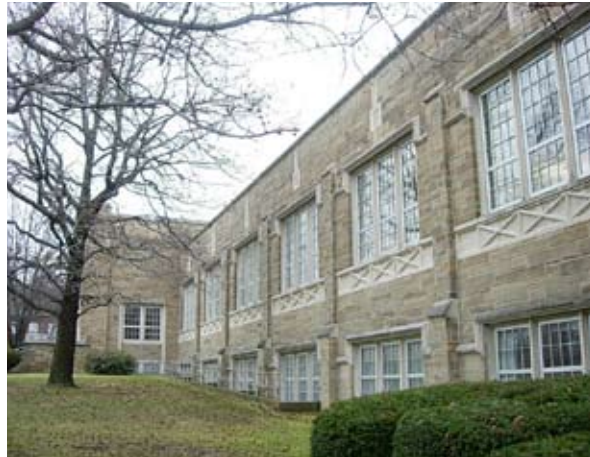
The Buhl Library is in excellent condition on the exterior and the recent aluminum windows are a good match the historic aluminum windows.

The significant interiors include the entry foyer with its decorative terrazzo tile floor, marble clad walls, and decorative aluminum staircase railing, as well as the lower level exhibit and rare book room space.

Since a planting plan exists for Buhl with plant list (left), we recommend that the landscaping be restored to its original intent. In the event plants are added or need to be replaced, we recommend that plant species be selected from the plan included in this report.

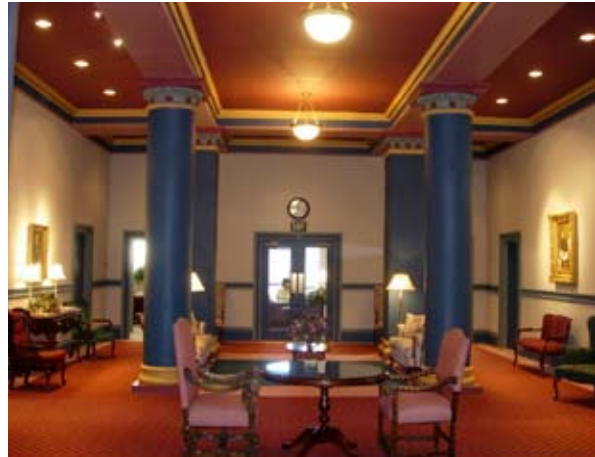
Carnegie Hall occupies a highly visible site and is an important part of Grove City College's shared history with the town of Grove City. Preliminary plans have been prepared for adaptive reuse of the building. The plans call for restoring the entry foyer, stair, and first floor to their original appearance. The open restored first floor space with decorative columns and ceiling will work well as a college reception center and multi purpose space.

The second floor has lost most of its seating and much of its plaster but retains much of its original wood detailing and is scheduled for adaptive use as offices.

Entry foyer and stairs: Consider paint research to restore original colors in this restored space.

Second floor: Plan the adaptive use to retain the character of the exterior walls, window openings and woodwork as well as the volume and profile of the historic ceiling.

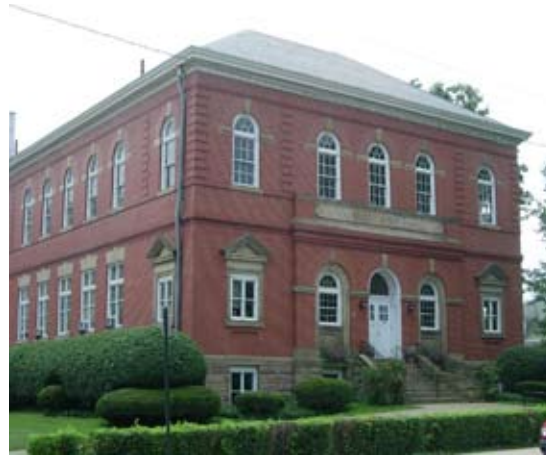
Carnegie Hall facing South Broad St.

- Remove manicured yews.
- Allow euonymus to grow out from building more naturally and reduce height.
- Consider planting a lawn tree (*Sophora japonica*) in the area of the Carnegie Alumni Center sign.
- Remove dead wood from sugar maple closest to Carnegie Alumni Center sign and deep root fertilize. Consider planting a new tree as an eventual replacement.
- Remove and replace two sugar maples flanking sidewalk.

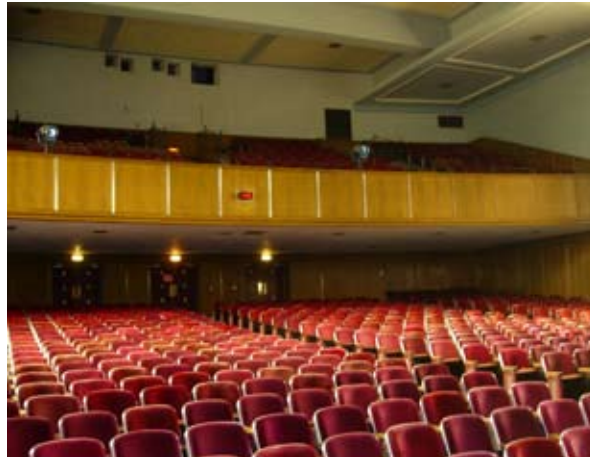
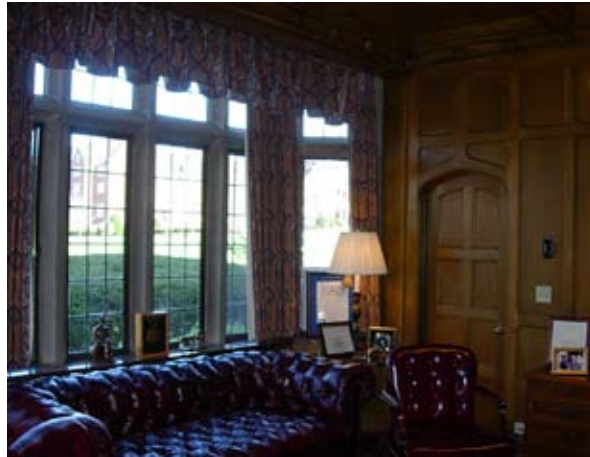
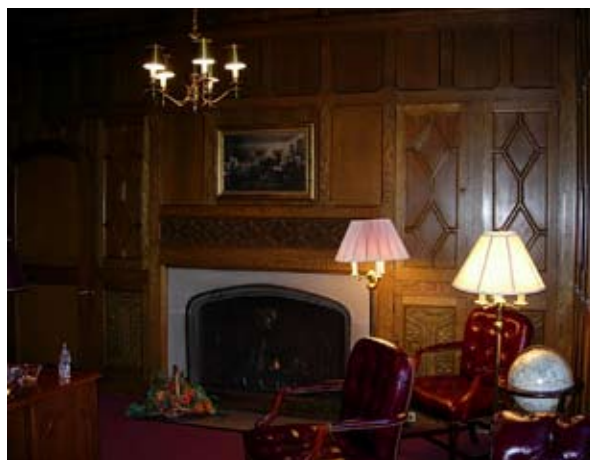
Crawford Hall

Auditorium: After the Harbison Chapel, the auditorium is Grove City College's highest-quality historic assembly space. While it has been maintained, the finishes have aged and the college needs the room to be retrofitted with a modern air conditioning and ventilating system. We propose the following approach to restoration of the auditorium.

- a. Conduct further research on historic elements of the space including paint finishes, lighting fixtures, floor finishes, and upholstery.
- b. The new HVAC system should utilize the four existing chases at the corners of the auditorium space for new ductwork and the existing ornamental grilles where possible. Where new supply or return grilles must be installed, grille design and placement should be carefully coordinated with the historic details of the space.

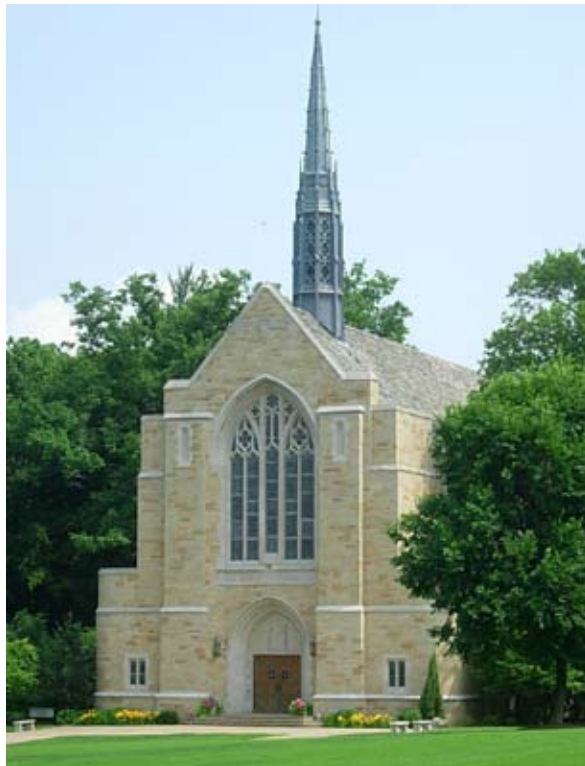
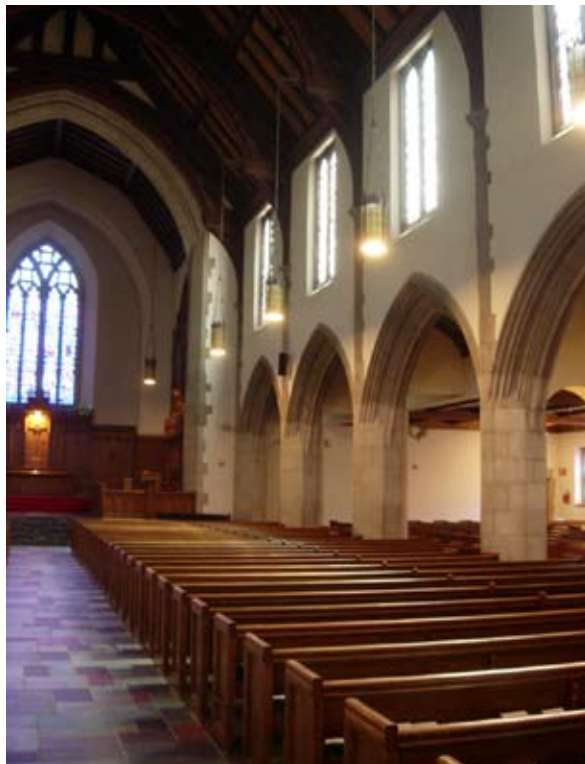
Harbison Chapel: facing the Quad.

Lighting Fixtures. The historic lighting fixtures in the nave have been retrofitted to cast light directly down onto the pews. While this improves light levels for chapel goers, the historic light levels in the upper chapel have been lost. We recommend restoring the upper level “lantern” lighting function to these fixtures. The original glowing lantern appearance of the light fixtures can be seen in the historic photograph in the building history section of this report.

Wood Ceiling: The polychrome wood ceiling will eventually require restoration. This should include cleaning using the gentlest methods possible, and then touch up painting where the original paint has worn away. We recommend this conservation method rather than over painting the historic finishes.

Stained Glass: Stained glass repairs can be undertaken by a qualified stained glass repair studio when needed. Storm windows should not be added. Energy efficiency is best gained by high efficiency central equipment and a control system which allows the space to be kept at moderate energy efficient temperatures when the space is not in use coupled with the ability to adjust the temperature and ventilation within the space during occupancy.

Flooring: The glazed tile floor requires touch up where the glazing has worn and periodic waxing. Use of harsh and abrasive cleaners should be avoided.

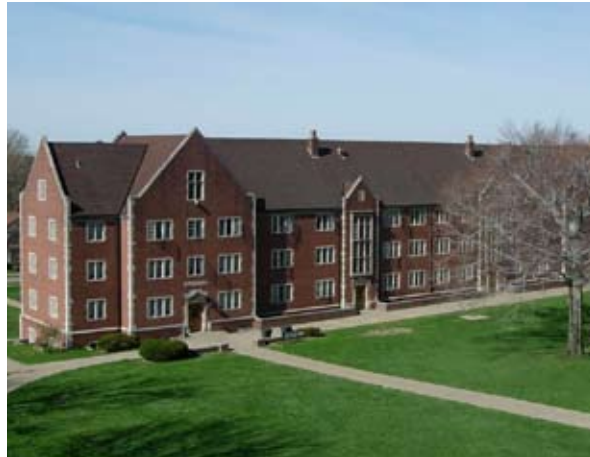
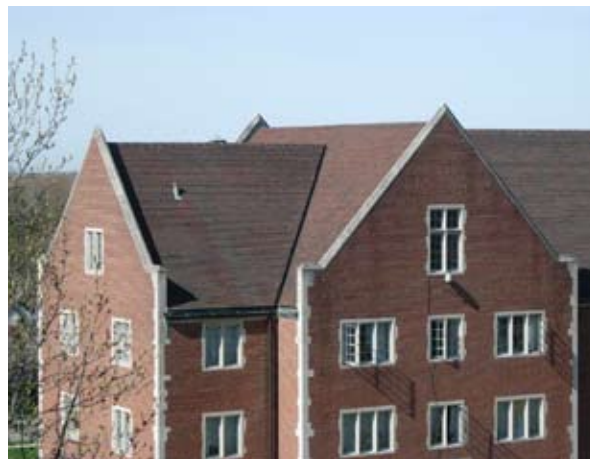
Hopeman Dormitory

- Remove lawn strip between yew hedge and sidewalk. Allow yews to grow naturally to soften building and allow growth to extend to sidewalk.
- Remove three arborvitae.
- Brick in unplanted areas in beds to each side of both entrance doors to eliminate weed growth.

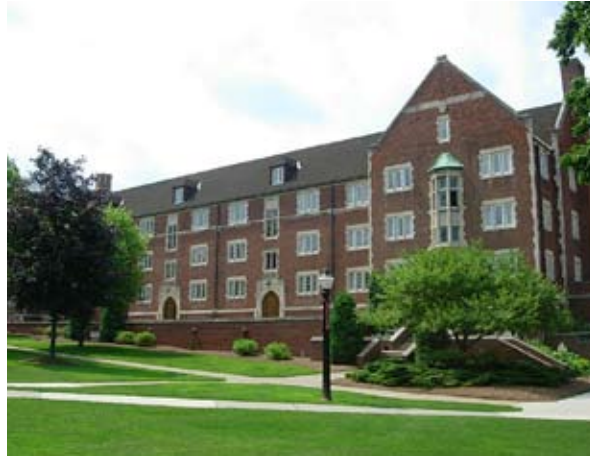
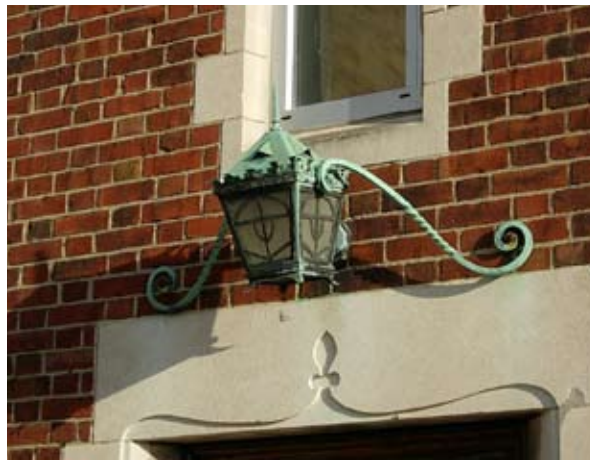
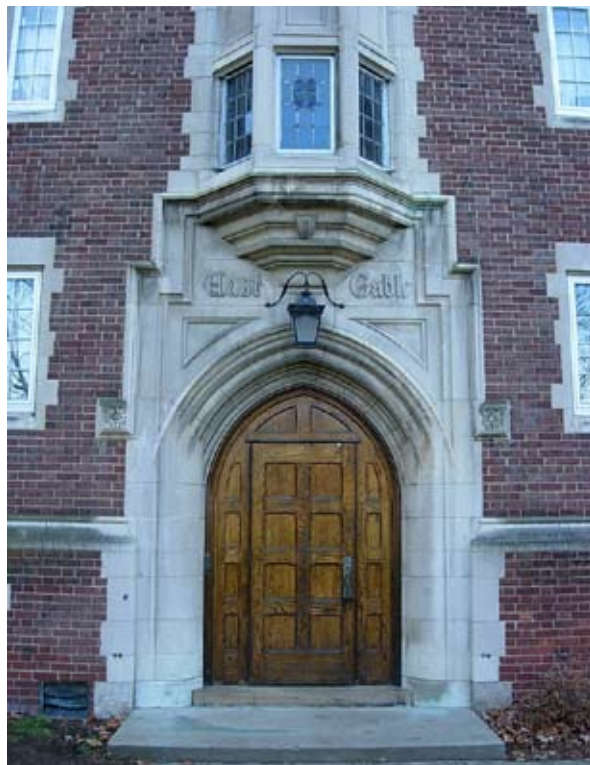
Ketler Dormitory

Recreation Room: This space suffers from underutilization. It was designed as a dining hall with paneled wood "zenitherm" wainscoting and decorative plaster walls and later expanded with a faux stone treatment of the walls. Future restoration projects should be based on historic drawings and photographs. The

room originally had much lighter stone and stucco colors on the walls and columns and decorative light fixtures.

Our recommendation is that the space be reused while retaining and restoring its character defining features.

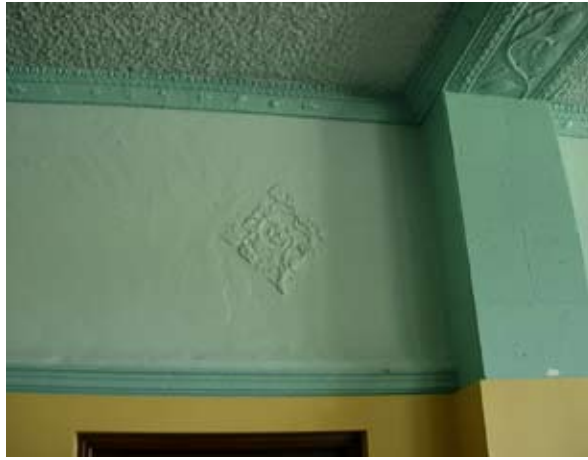
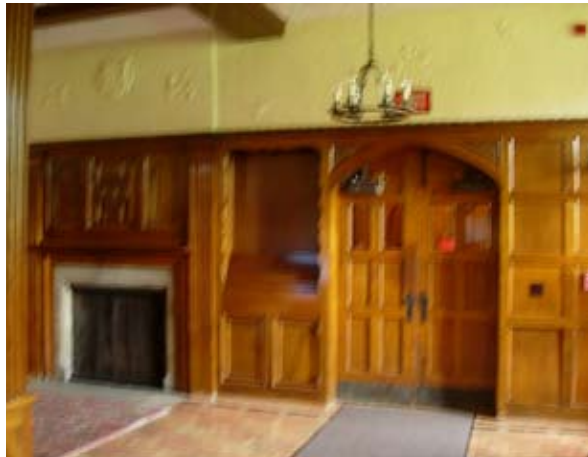
Ketler Dormitory

Oak Room: This exceptional space is highly detailed with an ornamental ceiling, paneled walls, mantled fireplace, “Old English” plastered walls, original lighting fixtures and ornamental aluminum railings. This space can be preserved as a quiet lounge and reading area. The room would benefit from returning its plaster walls to their original color. Consideration could be given to lightening the feel of the room by restoring the paneling to its original finish and/or adding supplemental indirect lighting.

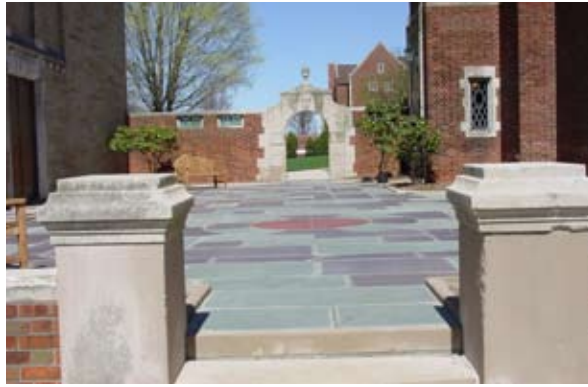
- Consider restoration of the bluestone entrance terrace. Replace damaged slabs and reset loose slabs in a manner consistent with original installation.
- Replace two Japanese weeping cherry trees left of entrance as part of efforts to replant all planting squares on terrace.
- “Snow Fountain” weeping cherry trees should be maintained for good health and to extend longevity.
- Augment native Mountain laurel right of entrance with two additional plants to fill gap.
- Remove yews and barberry. Replace with native Mountain laurel to replicate existing planting to right of entrance.
- Ivy on building should be kept at bay with regular trimming.

Blue stone terrace Mary Anderson Pew Dormitory.

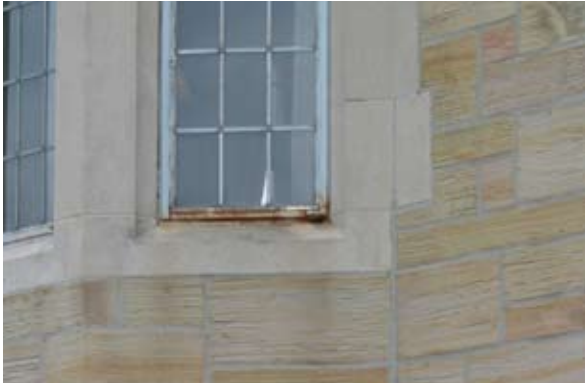
- Original steel casement windows.
- Some have deteriorated at the bottom edge of the sash and at the lower frame.

Scrape, prime, and paint casement windows where rusting to prevent staining on stone masonry.

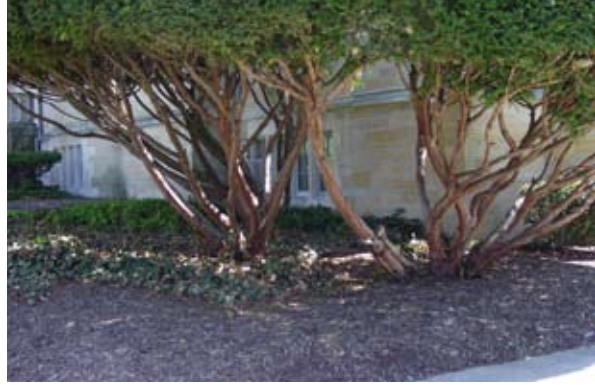
Mature yew shrubs with distinguished bark characteristic.

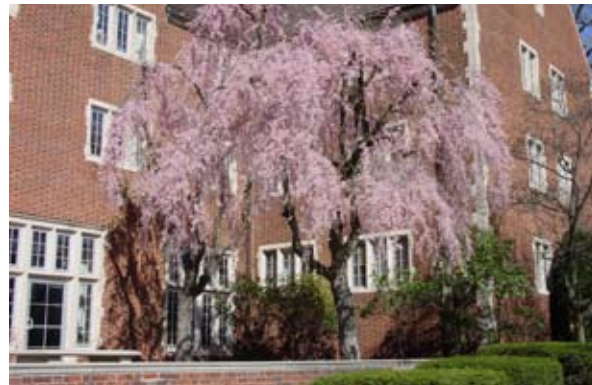
- Several bluestone slabs on entrance terrace are broken or loose and are potential tripping hazards. Overall surface is uneven due to settling.
- Japanese weeping cherry left of entrance is in poor condition as are yews and barberry shrub.

Weeping flowering cherry on terrace.
