PRESERVATION PLAN

GROVE CITY COLLEGE

The purpose of this plan is to outline recommendations for the preservation, conservation and continued use of the historic landscape and buildings of Grove City College.

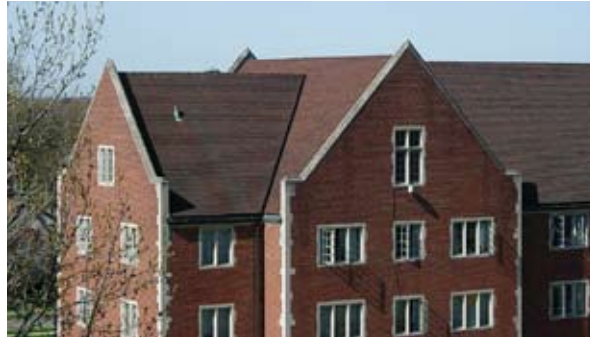
Roof covering example

Roof Coverings: When a roof covering must be replaced, use a new covering to match the historic one. Most roofs at Grove City College were slate or red tile. Both of these materials, if installed using copper or terne coated stainless steel flashing, are 80-100 year systems which have the advantage of having the lowest life cycle cost of all available options as well as being historically consistent with the original roof.

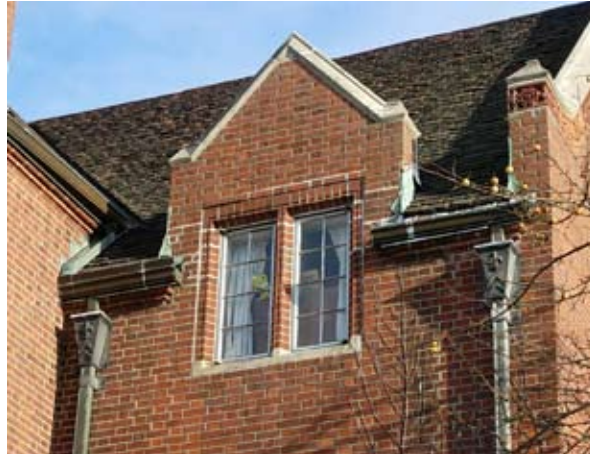
Window example

Windows: High quality steel casement windows are a character defining feature of the buildings of the Grove City College Historic Campus. Where windows are in fair condition and not subject to constant operation, retention of historic windows is preferable. Interior storm windows can be added in areas where heat loss or occupant comfort is a major concern.

Where windows must be replaced, a range of competing manufacturers should be solicited to assure that the best matching design is provided. Depending on the specific details of a given window, different manufacturers will provide a better match.

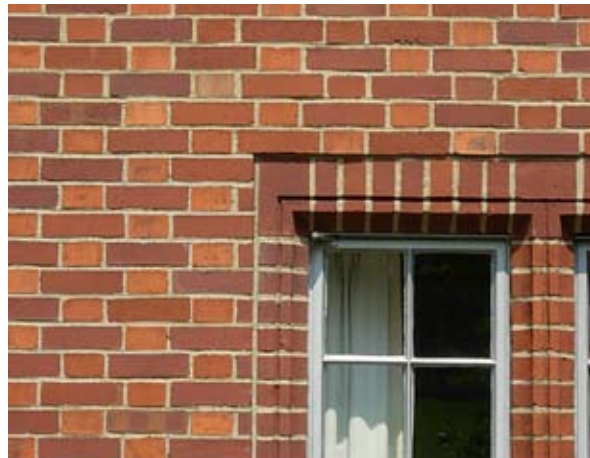
Masonry example

Masonry: The proper cleaning and re-pointing of historic brick and stone is now well known in the construction industry and is detailed in Preservation Brief #1 and #2 written by the National Park Service (available at <http://www.phlf.org/news/faq/>). These standards should be followed for all future masonry restoration.

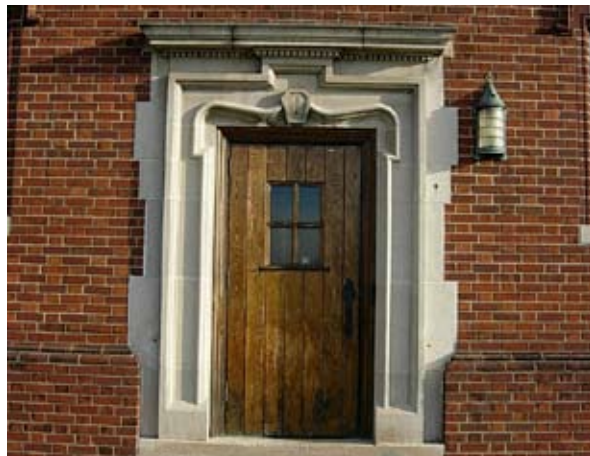
Door example

Exterior Doors: At the time the buildings were constructed, high quality old growth lumber was used for exterior doors. This is a very long lasting material and, if the current program of continued repair and re-staining is maintained, these will not require replacement. The doors are further distinguished by the use of high quality metal hardware.

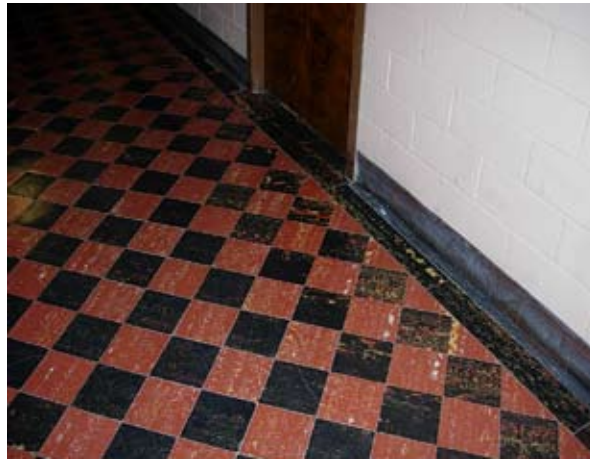
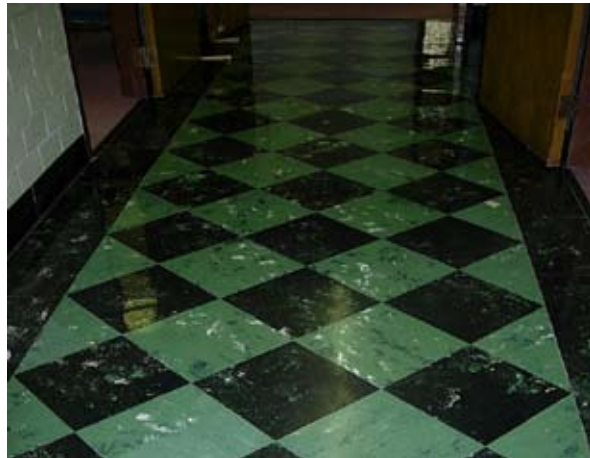
Tile Flooring: Exceptionally colorful patterns of vinyl or possible “zenitherm” flooring were in evidence within many of the buildings, especially Crawford, Mary Anderson Pew, Ketler, Lincoln and Hopeman. Vinyl tile flooring would have been a relatively new building product in the 1930s and 1940s. The colors chosen are strikingly bold, perhaps intended to evoke the rich colors seen in more expensive marble floors. These designs, while using modest building materials, are unique to Grove City College. We realize that wholesale restoration of this historic flooring is not practical given long-term maintenance and possible asbestos containing materials (ACM) issues, however, we recommend retaining portions in key areas where possible. Historic drawings refer to “zenitherm” which was a composite product meant to imitate stone. It is possible some of this highly colored flooring in Mary Anderson Pew or Crawford may be the historic product rather than vinyl.

Vinyl-tile floor covering

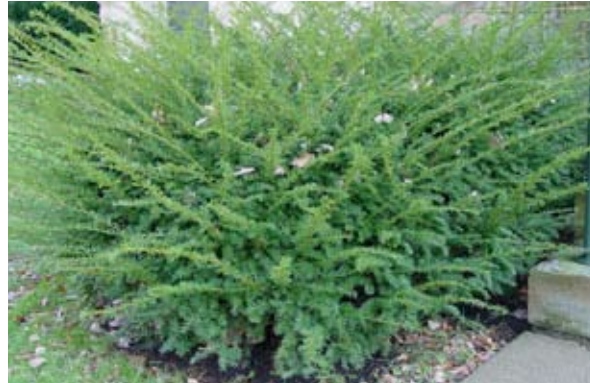
Example of a Yew that is allowed to grow unencumbered in its natural shape. Prune, don't shear.

Pruning: The majority of shrub plantings are overly manicured and improperly pruned. It is recommended that shearing of shrubs be discontinued and that hand pruning and thinning be utilized instead to retain a plant's natural growth habit. A maintenance program of pruning of campus and street trees should be considered every two to three years to be implemented either by the grounds crew or by a professional company.

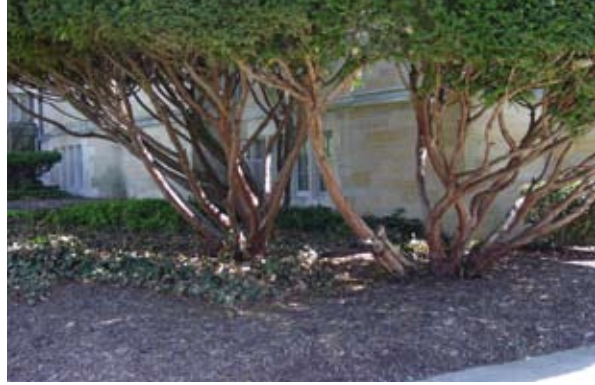
- Bluestone entrance terrace has significant deterioration.
- Crabapple at northeast corner is 90% dead.
- Crabapple left of doors has water sprouts.
- Yews have a nice ornamental bark feature characteristic of maturity. Could be from an original planting.

Mature yew shrubs with distinguished bark characteristic.

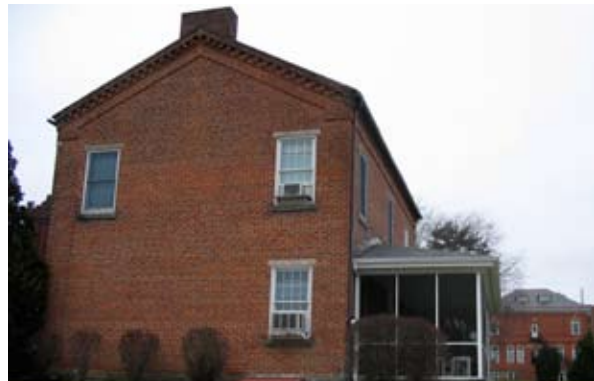
Unightly window air conditioning units detract from the historic visual character of the building.

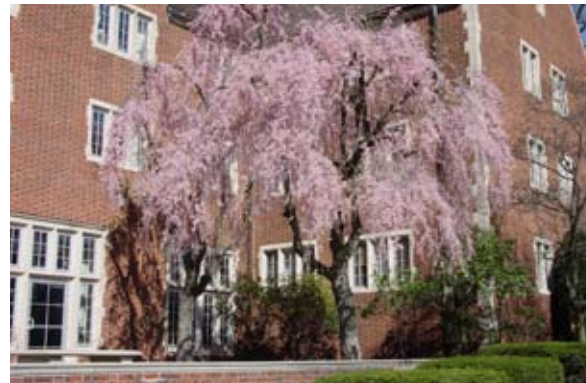
- Barberry shrub left of approach to terrace is out of place and is an invasive species.
- Weeping cherry right of terrace is declining. Weeping cherry to left is dead.

Weeping flowering cherry on terrace.

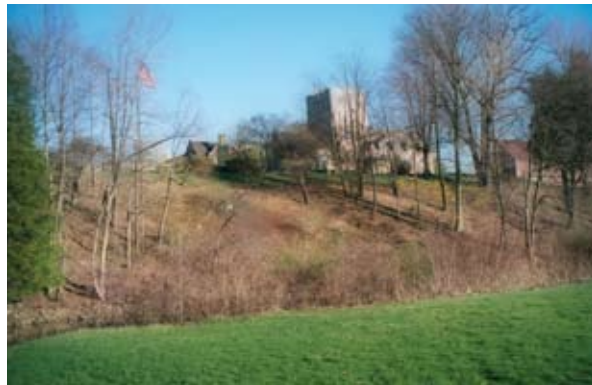
- Upper area is primarily lawn interspersed with surviving Mountain laurel possibly from the 1946 landscape plan.
- Proliferation of native sassafras trees has become established and looks appropriate to this natural area.
- A large number of mature deciduous and evergreen trees, possibly from the 1946 plan such as red and white oaks, beech hemlock, sugar and red maples.
- To either side of stairs leading to Rainbow Bridge, mass plantings of native Mountain laurel, rhododendrons and forsythia exist. Large gap noted on right at top of stairs. Gaps in planting noted at bottom of stairs.
- Underbrush and bramble was noted at bottom of stairs on right.
- Bittersweet vine is suffocating rhododendrons and native Mountain laurel.
- Creek embankment to the right of Rainbow Bridge is eroding and devoid of vegetation. Lawn area is devoid of trees.

Same hillside, different view.
